INSPECTION REPORT

sample

4 Site Building Inspections Inc

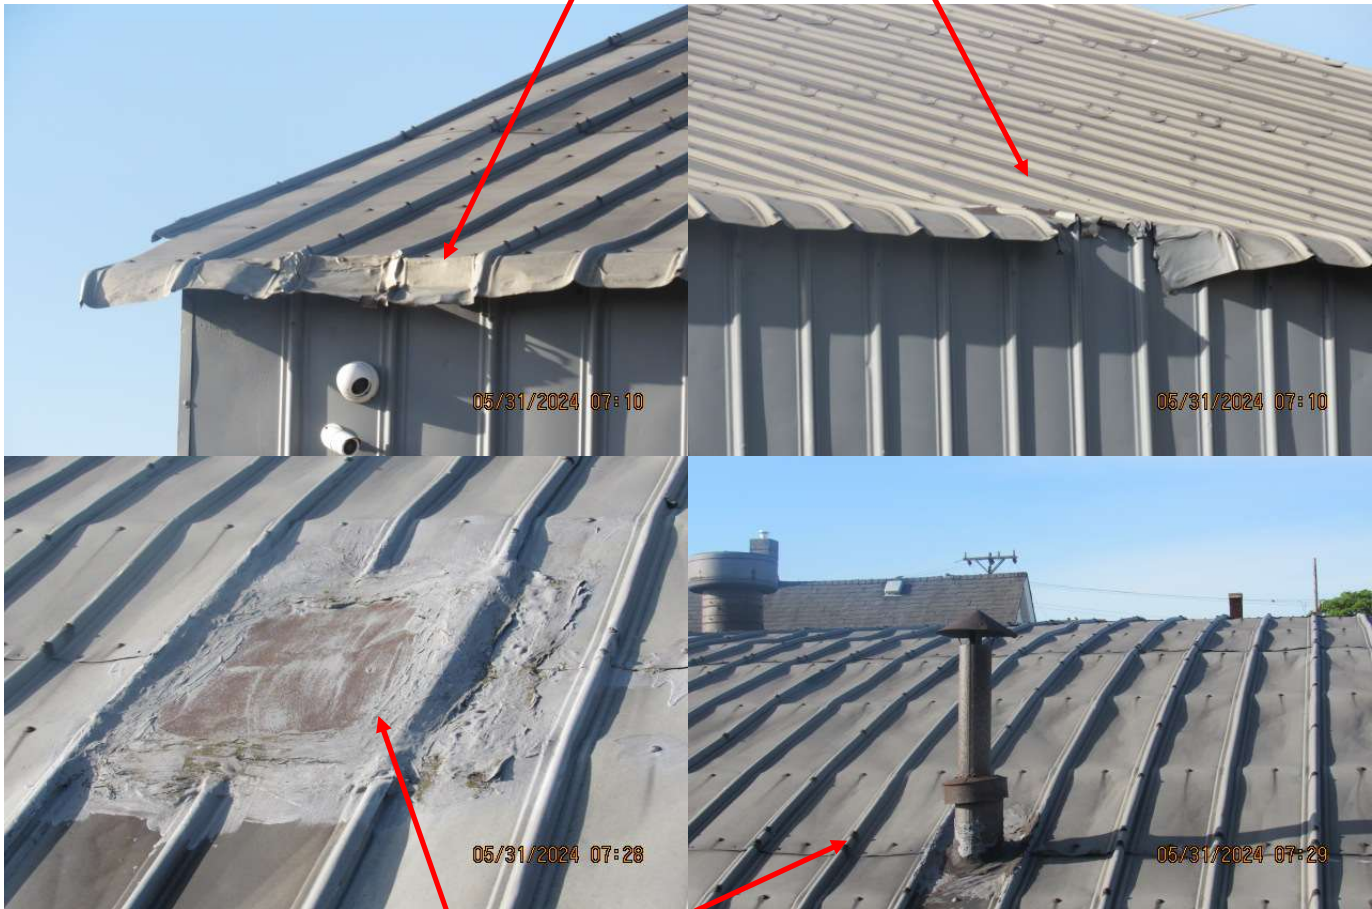
- The sloped metal roofing on both main buildings is nearing the end of life expectancy. The roofs have been poorly patched and have damage in multiple areas. The panel fasteners and fastener seals are poor throughout. A Certified Roofer should evaluate the roof system for repairs.

- Repairs may help extend the life of the roof. A budget should be set aside for roof replacement in the future.

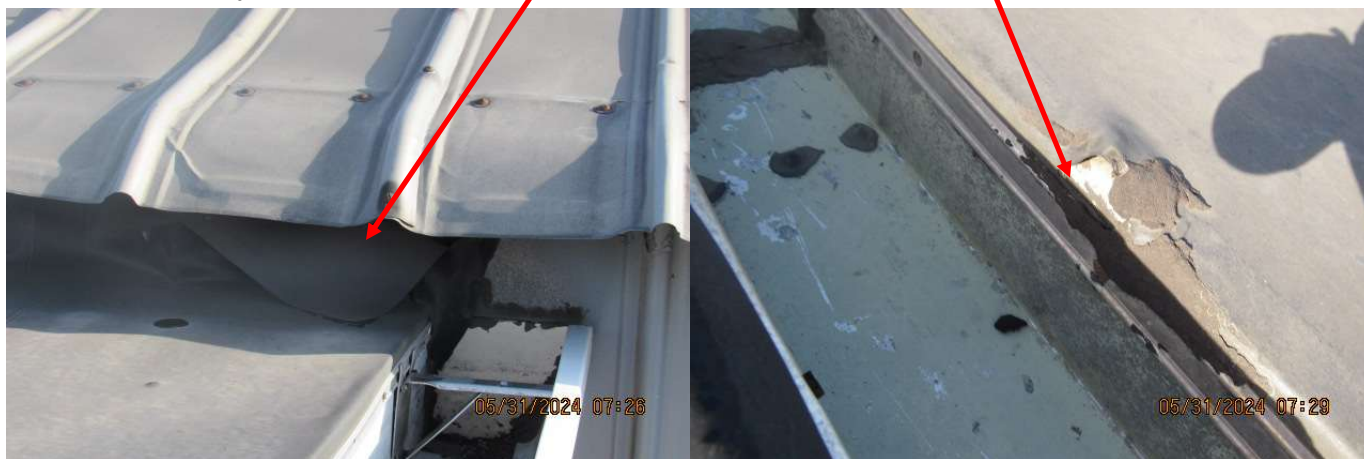
3. Rubber roof transition flashing appears to be incomplete in some areas. The seams at some termination bars are poor. A Roofer should make repairs to the rubber roof.

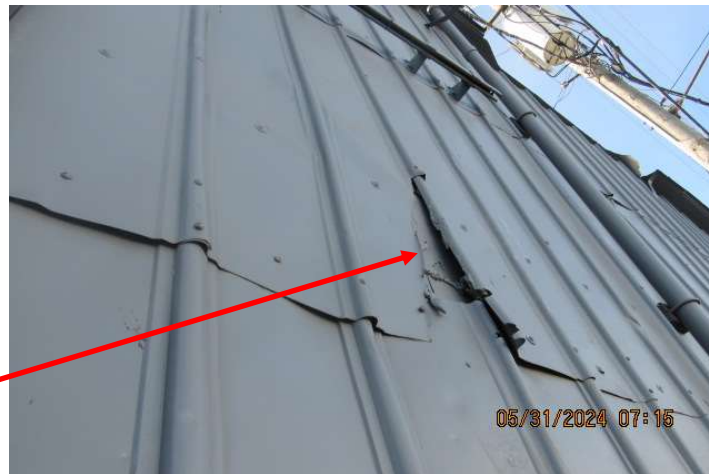
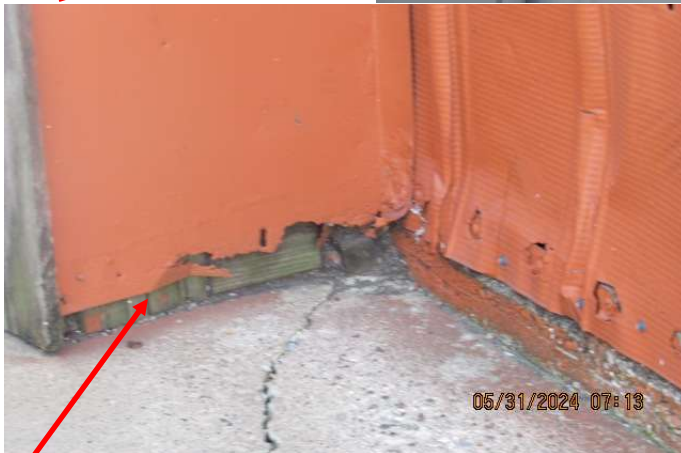
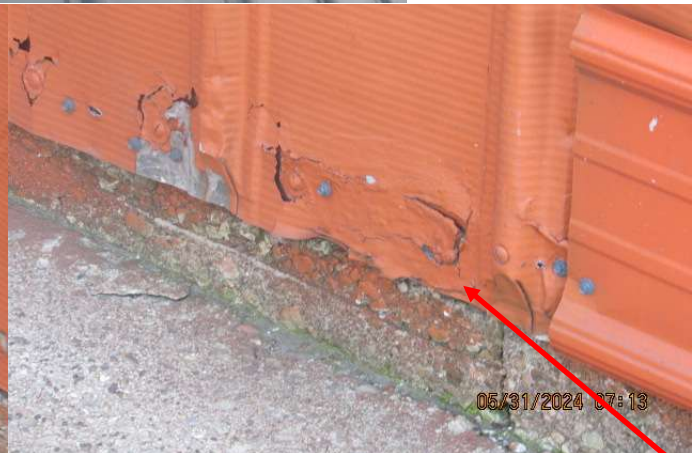
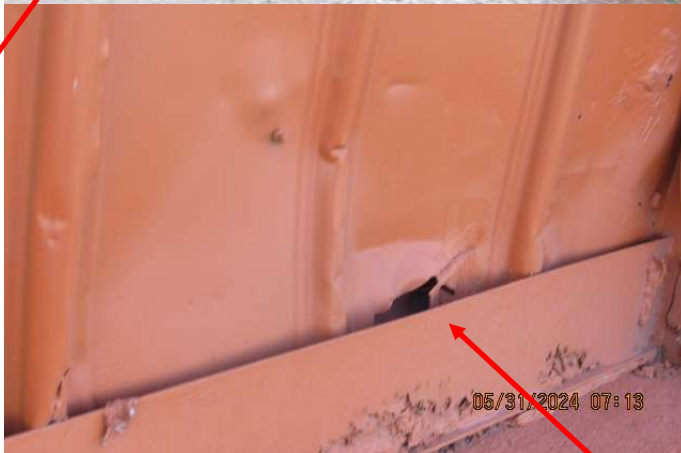
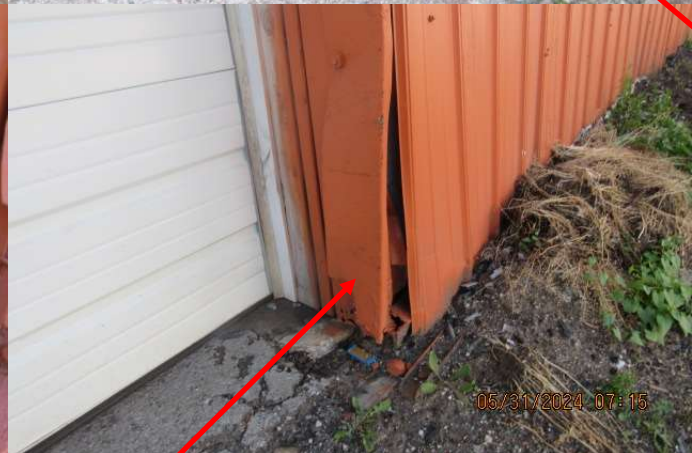
- The siding throughout both attached buildings is in poor condition. The siding is old and damaged in various areas. There are some areas where a second layer of siding covers the older/damaged/deteriorated siding for the first 48" along the bottom improperly. There is no flashing and the siding sits improperly at grade.

Multiple wall vents are also damaged. Cats are entering the building through voids in the wall. A Siding contractor should evaluate the siding throughout for replacement.

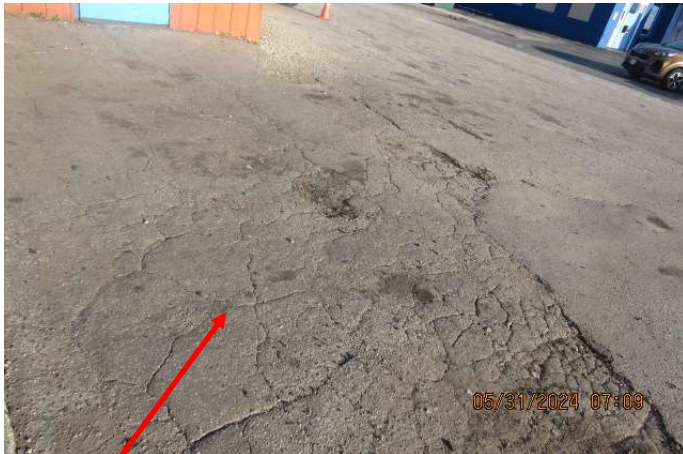
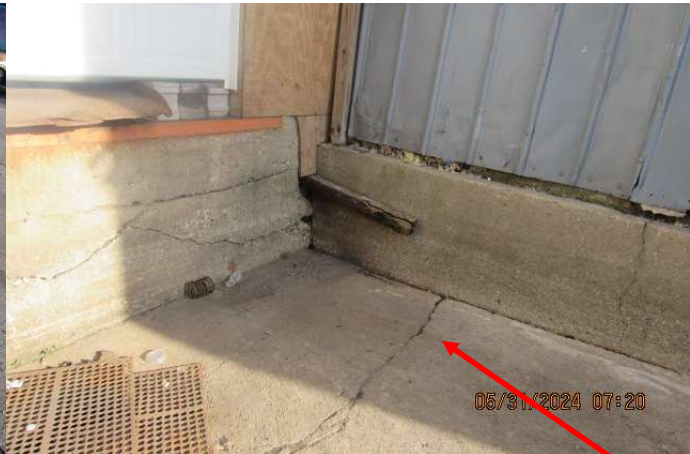
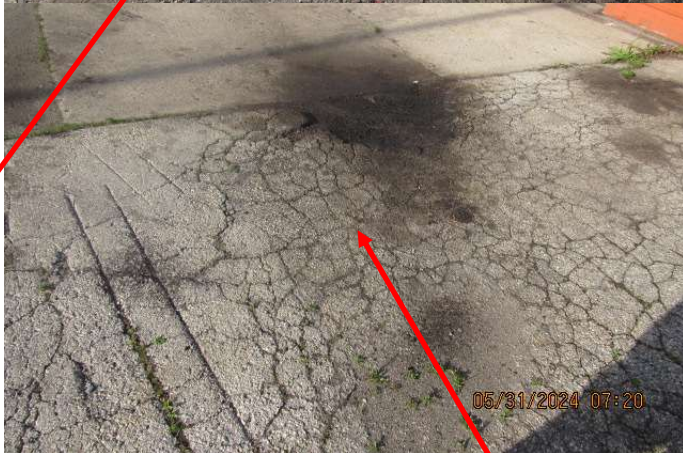
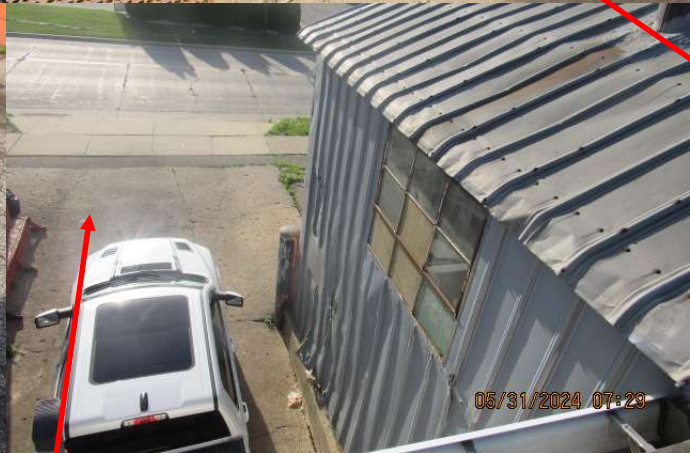
8. The parking lot is in need of repairs/maintenance throughout. Some areas are in deteriorated condition and need repairs. Rear driveways show signs of cracking. The dock driveway is damaged as well. The property line should be confirmed and repairs should be made.

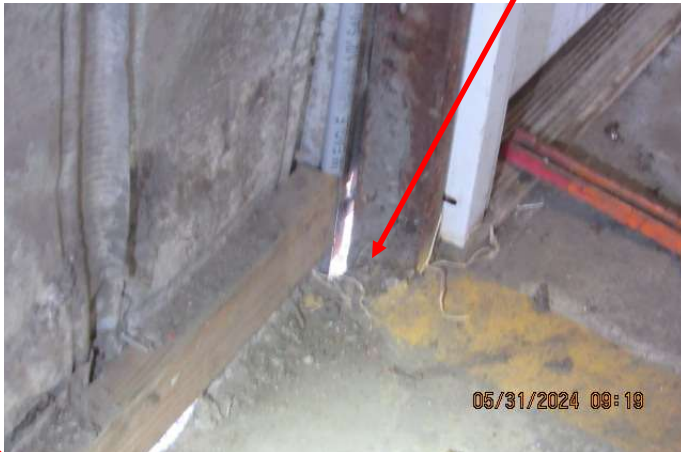
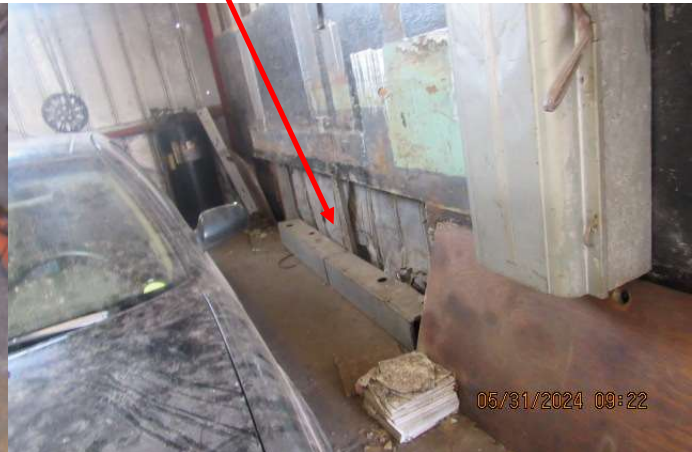
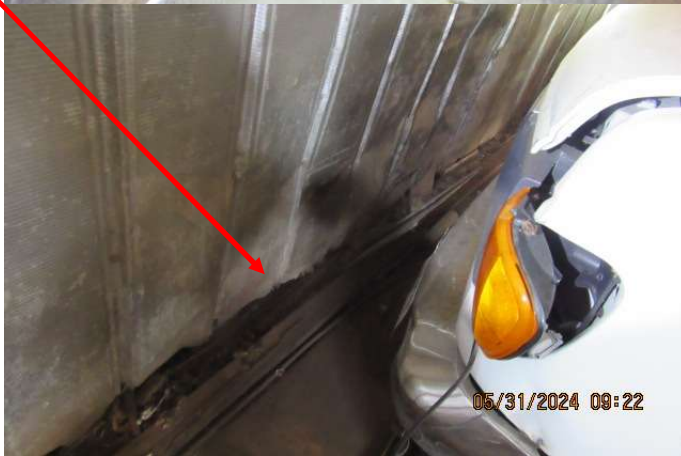
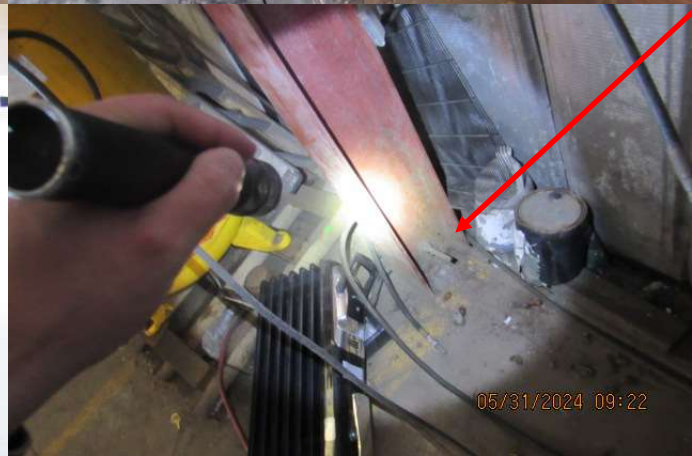
14. There are various areas in the South building where the wall framing is rusted and disconnected near the sill. The walls are also out of plumb at the rear. Structural repairs are needed in these areas.

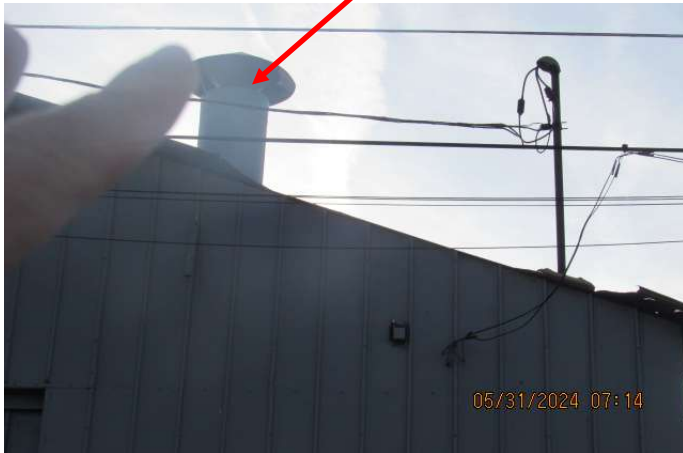
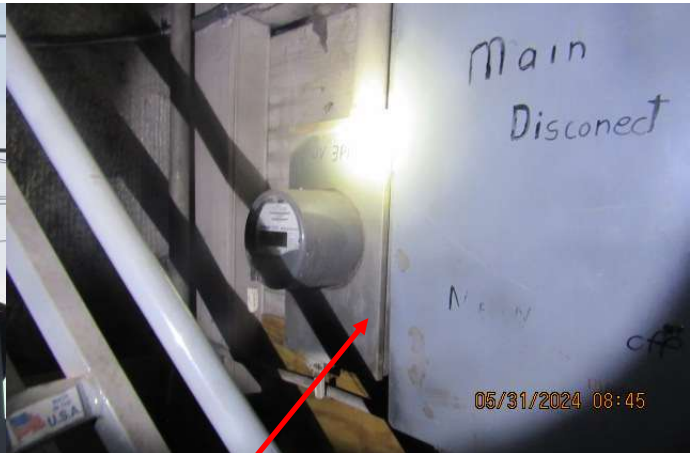
15. The electrical service drop has poor clearances over the South Roof line. Alterations are recommended.

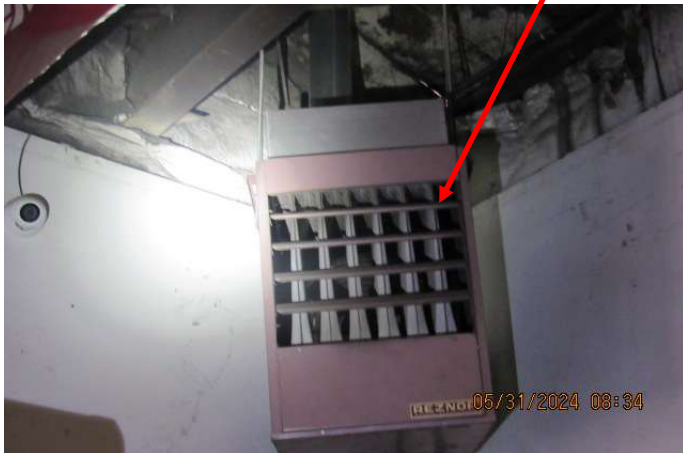
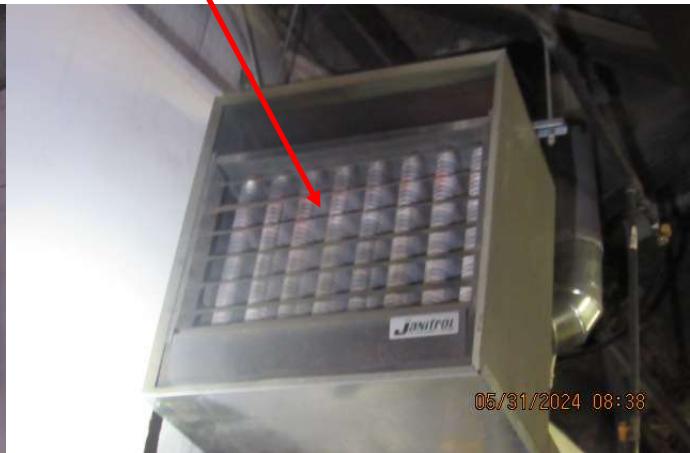
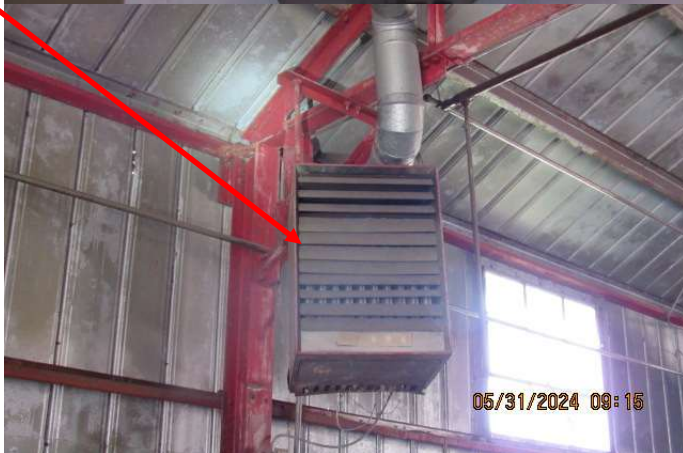
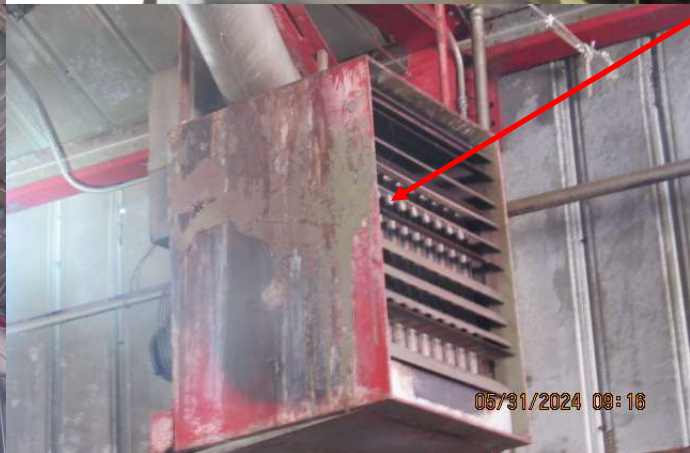
24. 5 hanging furnaces are inoperable and/or past life expectancy. These old furnaces can be unsafe to use. Flue connections are rusted and damaged. Replacement is recommended of the old furnaces and repairs to flues/thermostats are recommended.

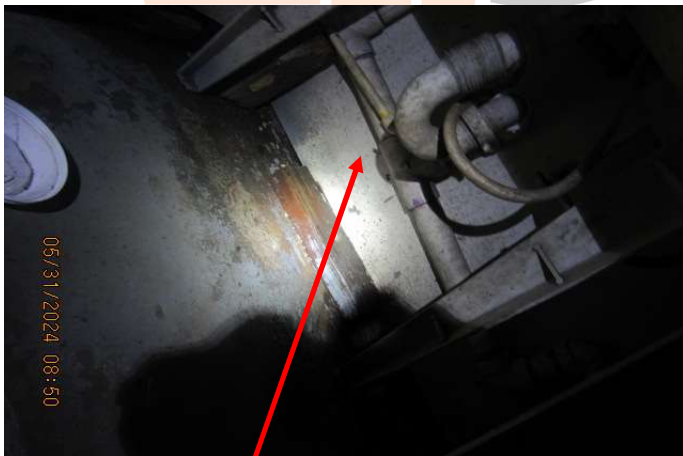
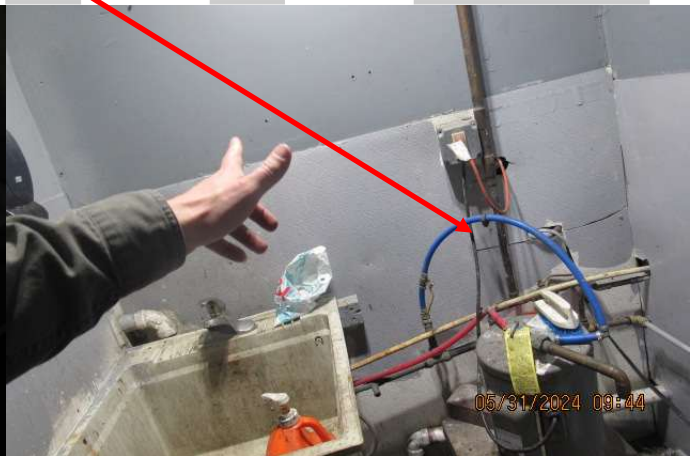
30. The Water Meter is blocked and there is limited access to the main shut off. The Plumbing in this area may also be prone to freezing. A Licensed Plumber should evaluate this configuration for repairs.

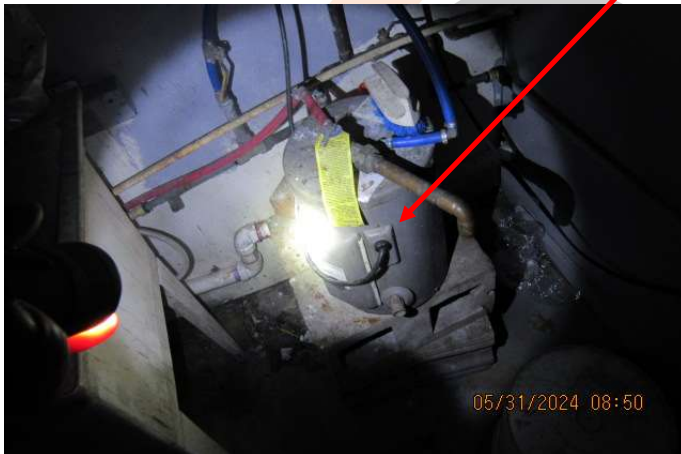
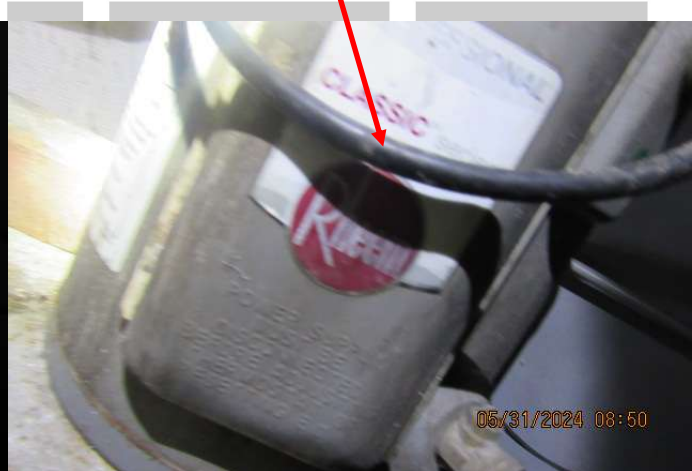
34. The water heater is an old unit that may be approaching the end of its useful life. It would be wise to budget for a new unit. One cannot predict with certainty when replacement will become necessary.

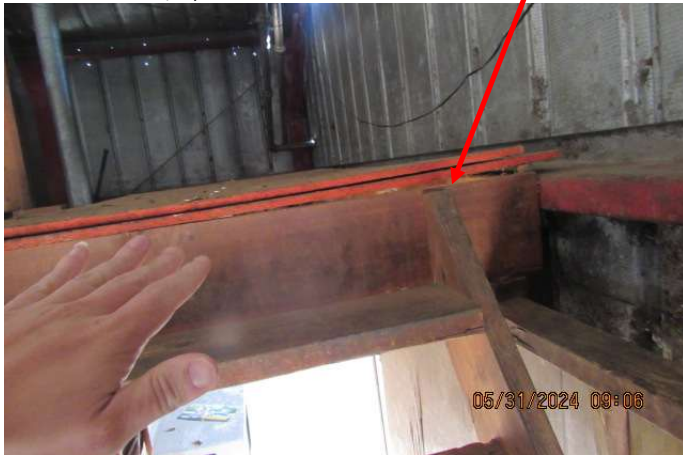
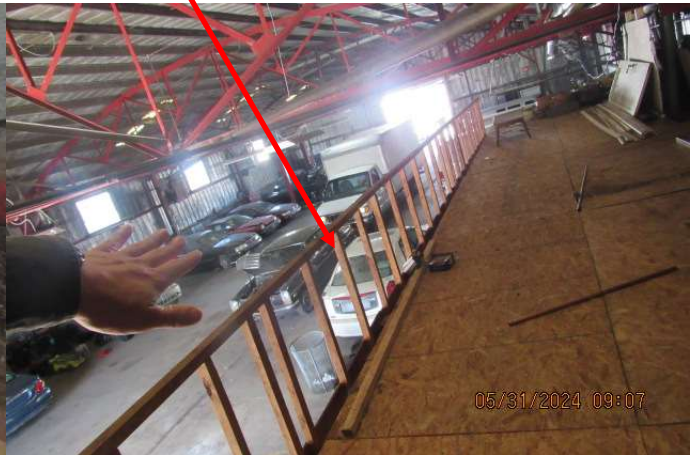
46. The stair and second level configuration is a fall hazard. Stairs are too steep, spacing in the guard rail is too large. Decking is poor and head clearances are poor on the second level. A Carpenter should make improvements.

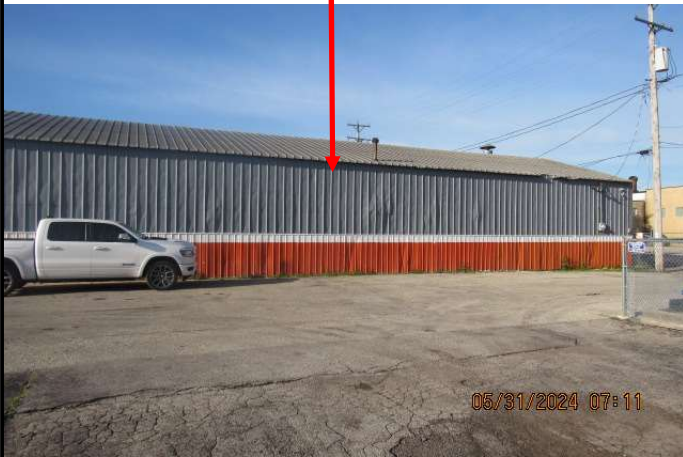
Rear exterior door has been sealed.

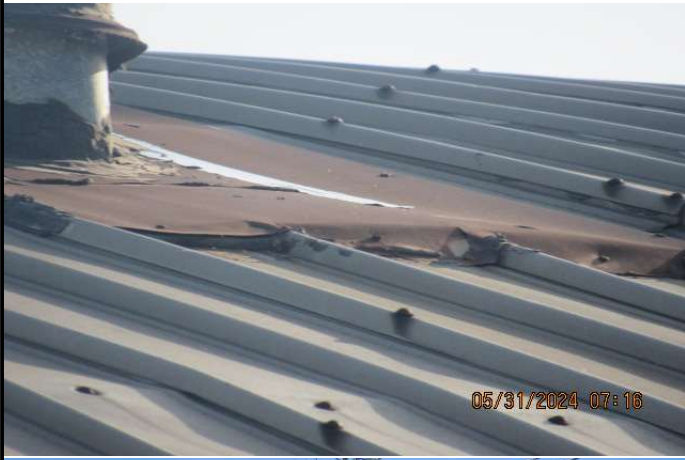
Old roof patches
