INSPECTION REPORT

4 Site Building Inspections Inc

Thursday, May 29, 2025

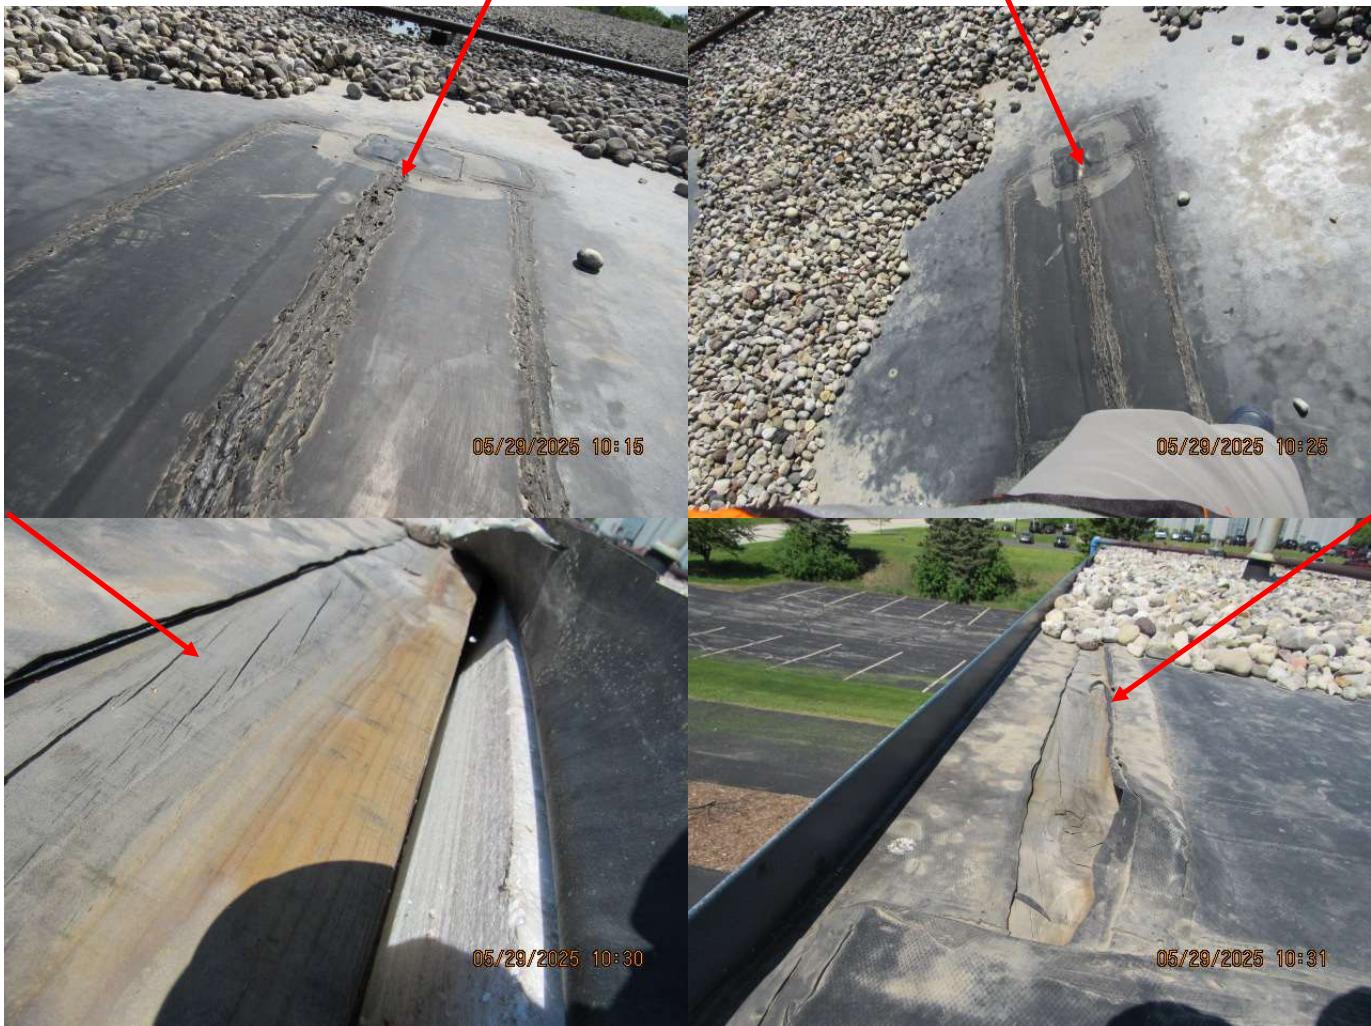
1. Damaged roofing was noted at the south side of the building. Framing is exposed and active water damage was noted in this area. Some seams are poor or loose. Ballast is poorly spread out and limiting proper drainage. Repairs are needed immediately.

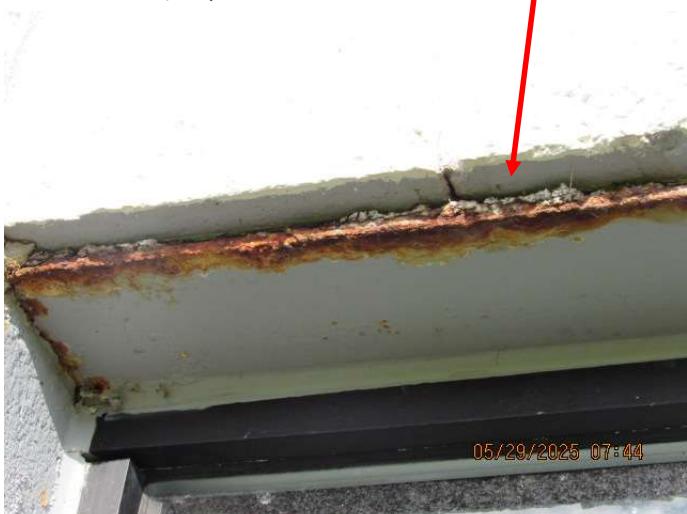
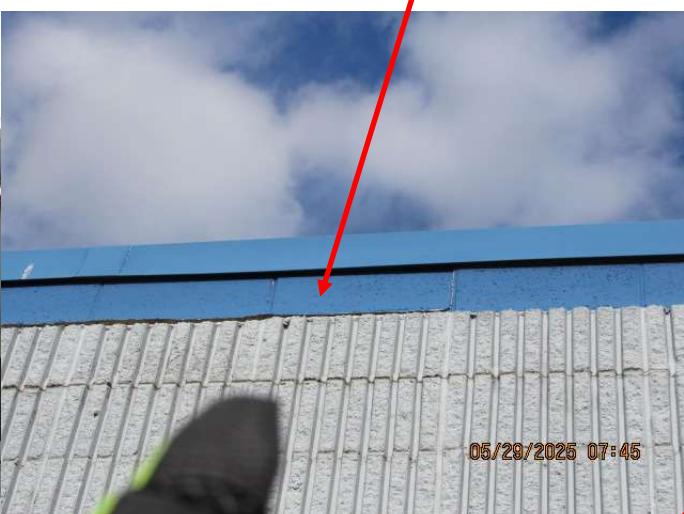
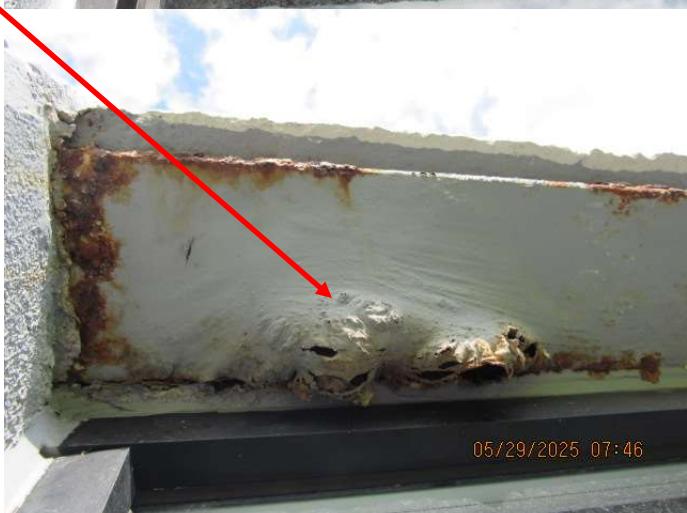
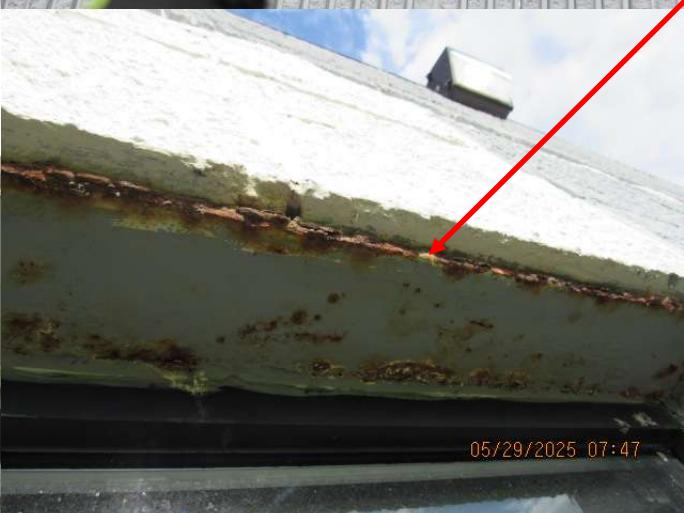
3. The block has been painted which can trap moisture. The block lacks proper weeps or weeps are blocked at lintels. Most lintels show signs of rust and water entrapment. A front entry column shows signs of settlement and damaged block. Block at the top of the East wall are tilted and need repairs. A Mason should be consulted to make repairs to the lintels, add weeps and make block repairs.

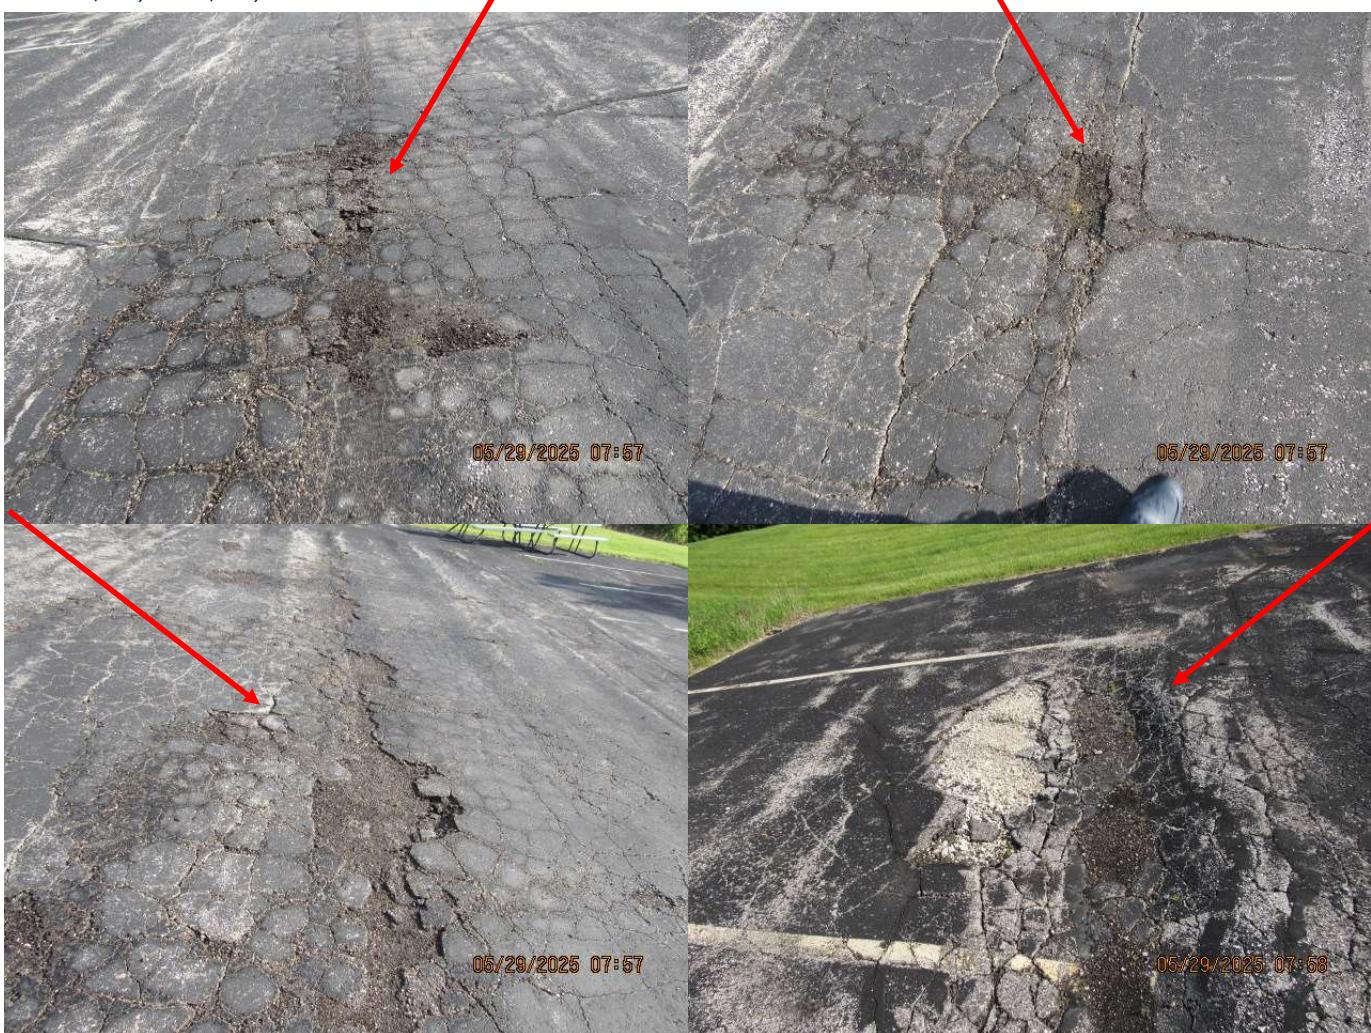
10. The side parking lot is in need of maintenance/repairs. Some areas are deteriorated and will need replacement.

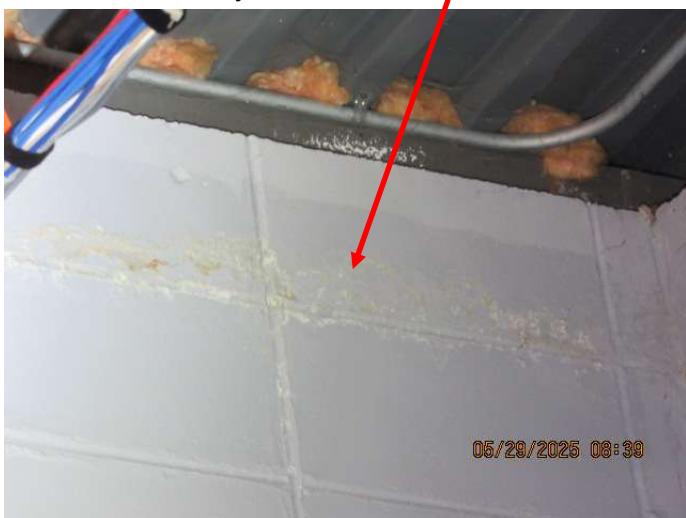
12. Some block shows signs of moisture intrusion.

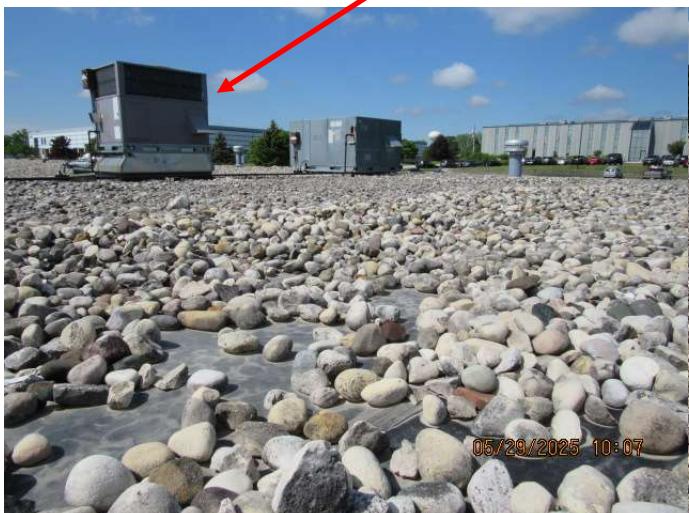
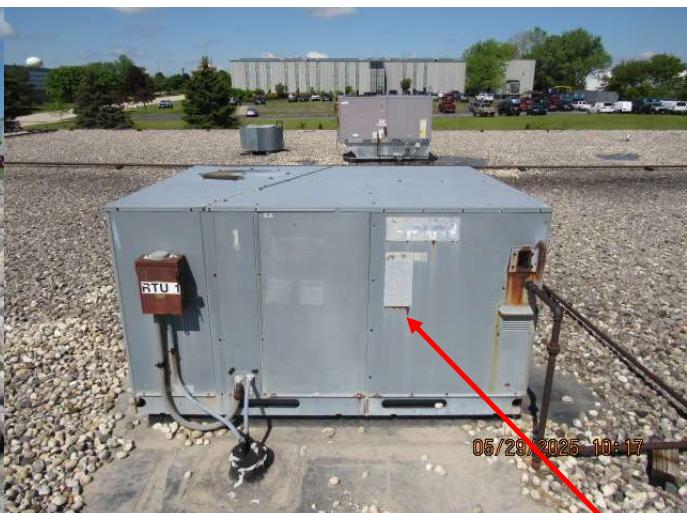
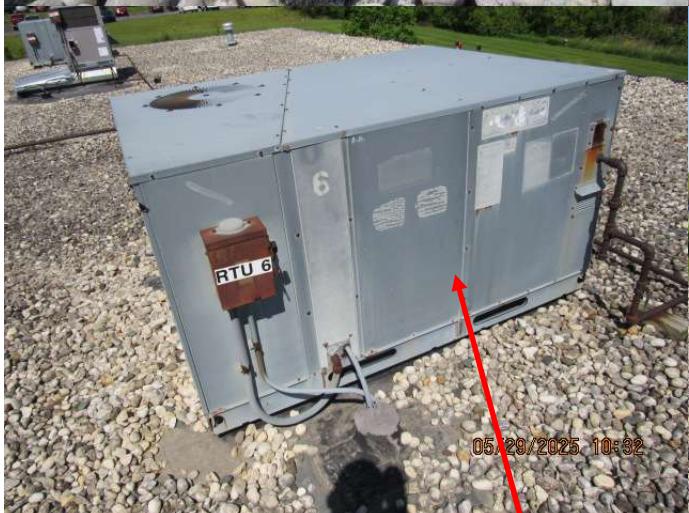
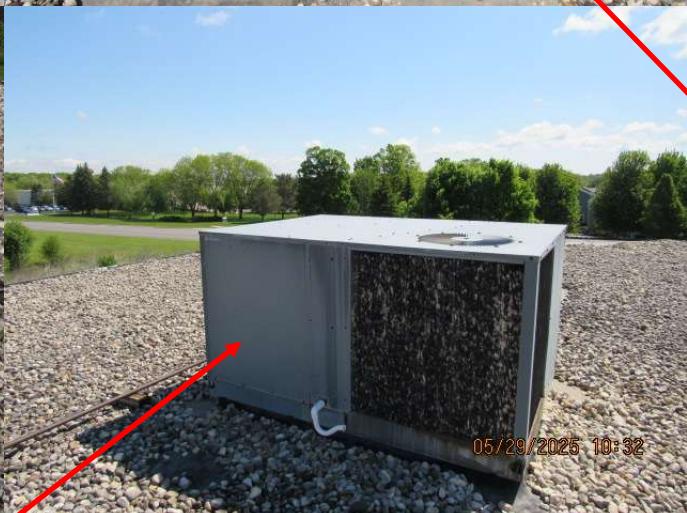
19. The RTUS are in need of service/maintenance by a hvac contractor. Filters should be replaced and exterior fins should be improved.

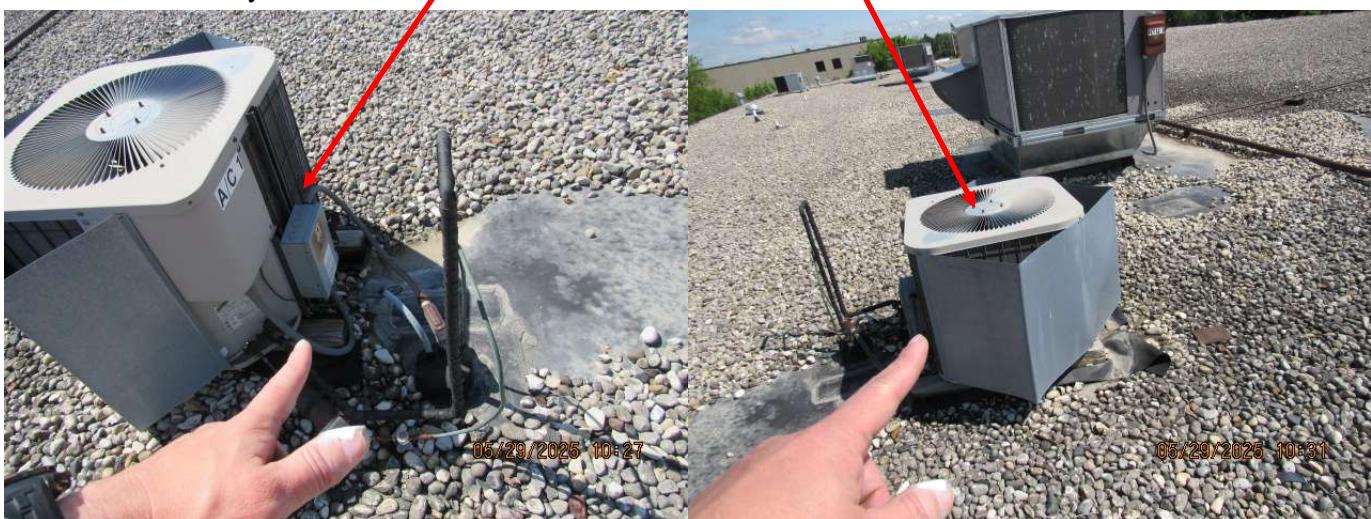
26. The central air unit on the roof is in poor condition and is past life expectancy. It is suspected that this unit is abandoned. No air handler for the unit was located. A HVAC contractor should confirm and properly terminate the unit as needed.

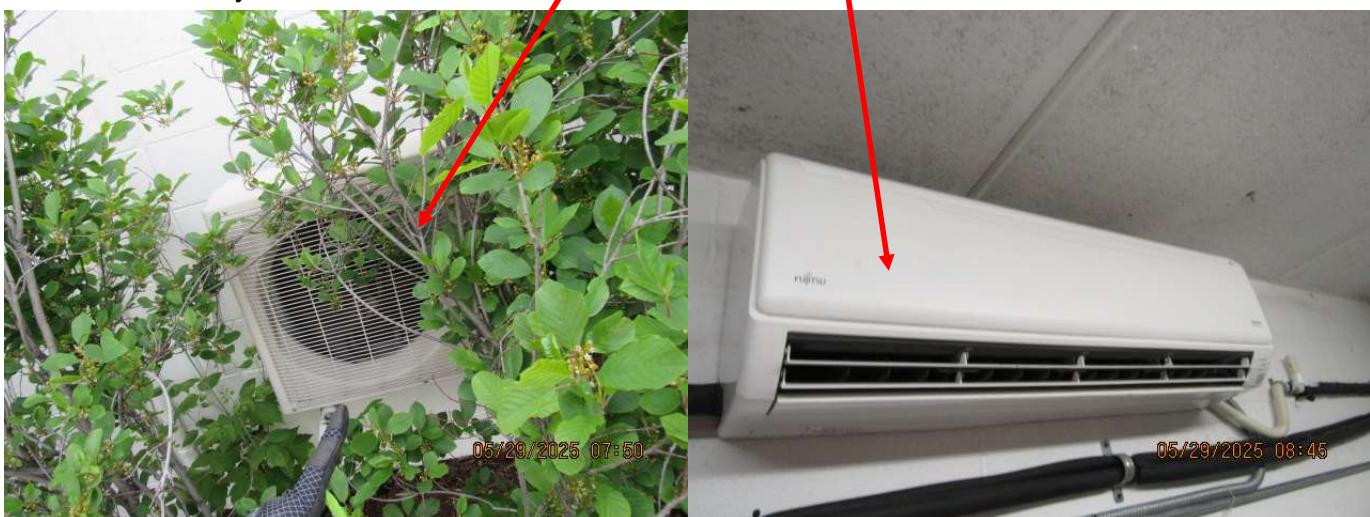
27. The split unit responded to testing. The unit is in need of service/cleaning. Landscaping should be trimmed away from the exterior components.

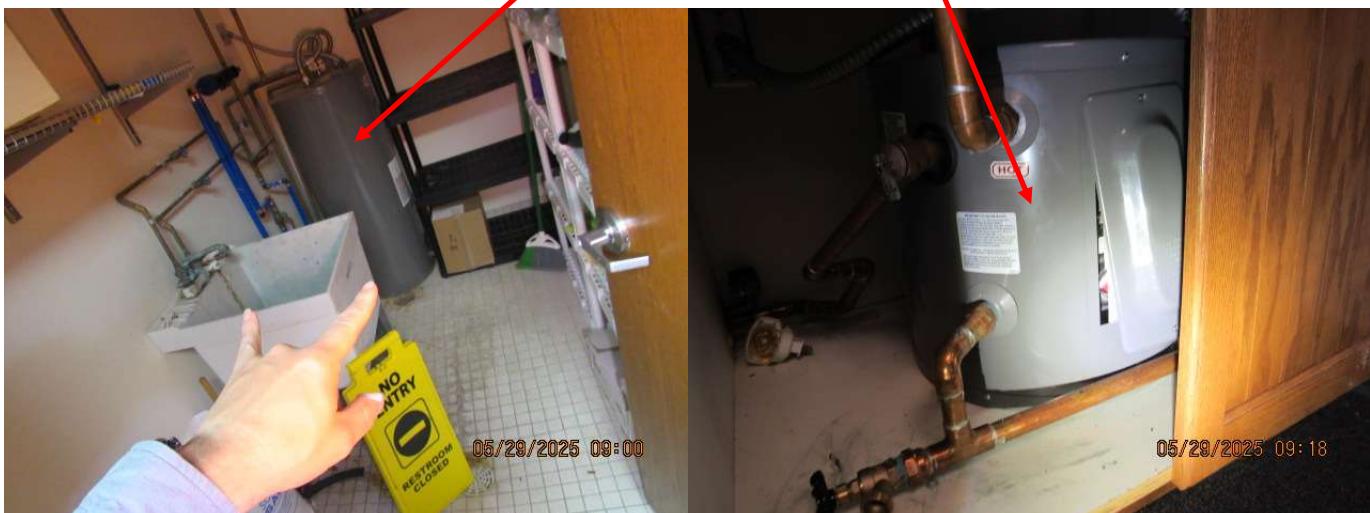
34. The water heaters show signs of age and will need replacement in the near future.

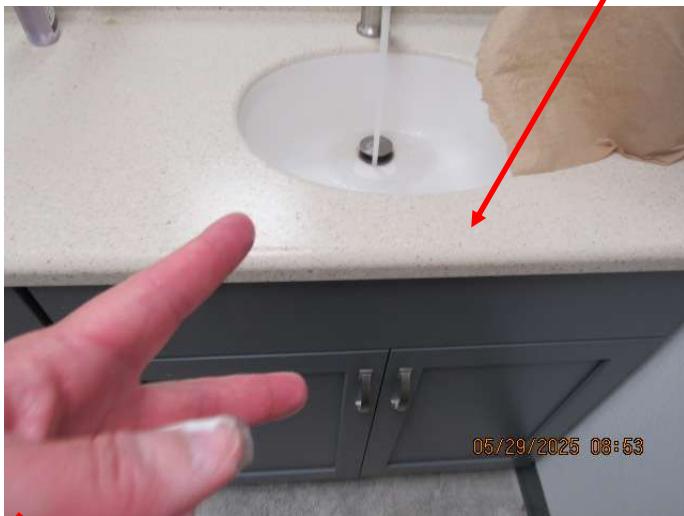
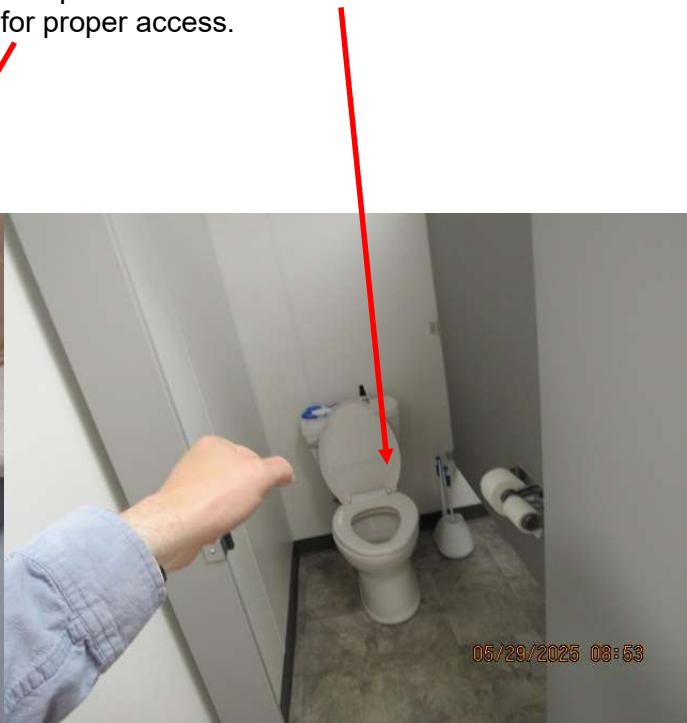
39. The bathrooms are marked as handicap accessible. Toilet stalls lack proper spacing, hand rails and the toilets are not the proper height. Sinks should have space below for wheel chair access as well. Remodeling of these spaces are recommended for proper access.

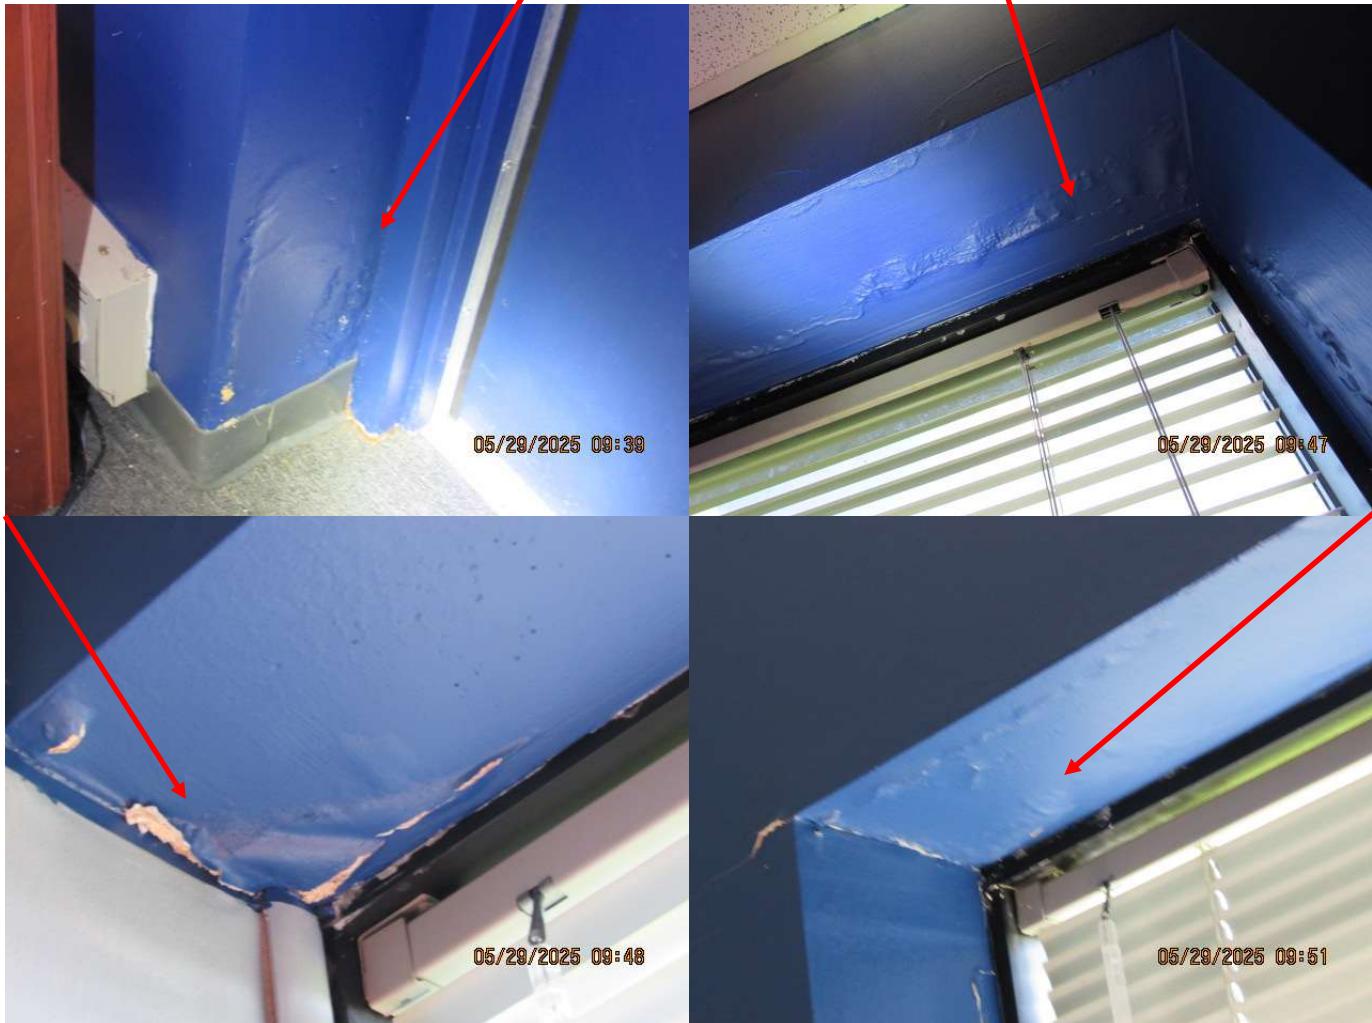
41. Extensive water damage/intrusion was noted around various doors/windows. Some ceiling tiles have water stains as well. The cause of and extent of the water damage should be investigated and repaired.

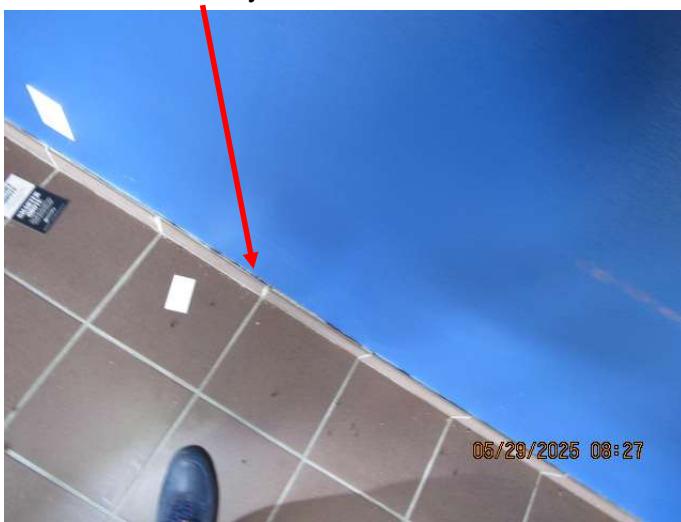
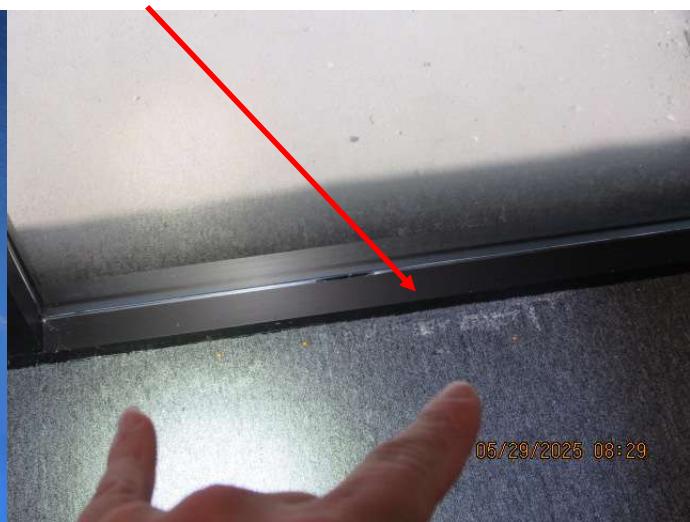
Moisture intrusion at front entrance window.
