# Inspection Report

Milwaukee WI 53228

December 18, 2019

## 4 Site Building Inspections LLC

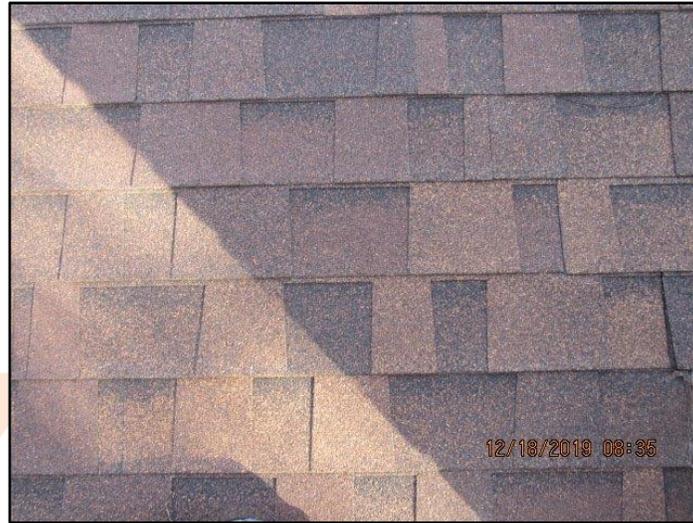
1. The roofing is in fair condition but has been installed using poor workmanship and some shingles are over exposed.

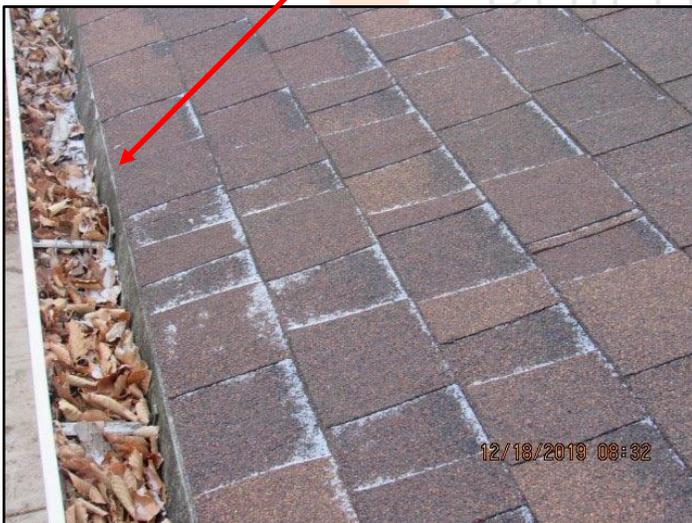
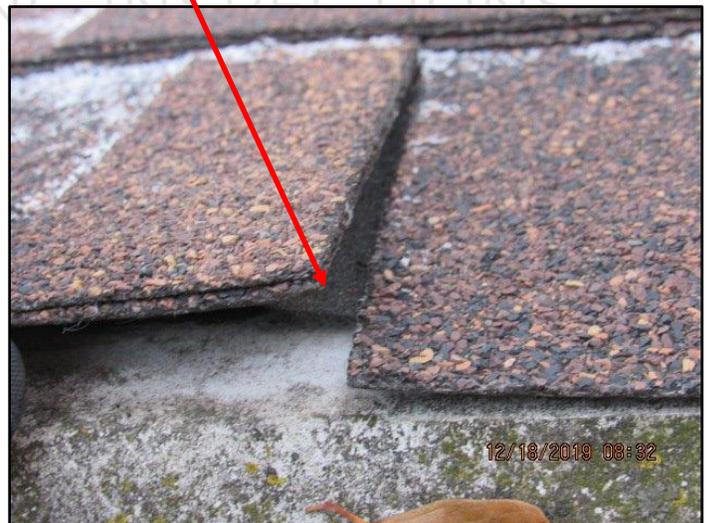
2. The roofing system lacks a proper starter strip and some shingles are over exposed. I suggest that a roofer evaluate this system to make repairs as needed.

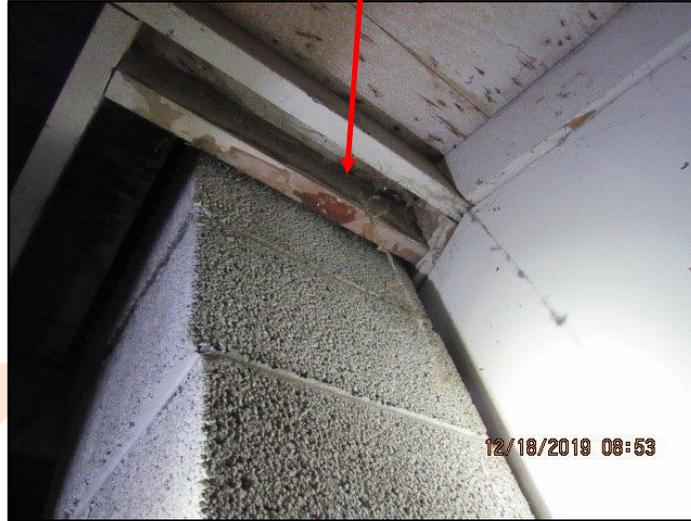
3. The Flashing around the mechanical chimney was loose and was recently caulked but there was active water drips and staining below that chimney. I suggest that a roofer or flashing specialist evaluate this flashing for a proper repair. The roof wall siding clearance is also improper and there is staining below this area.

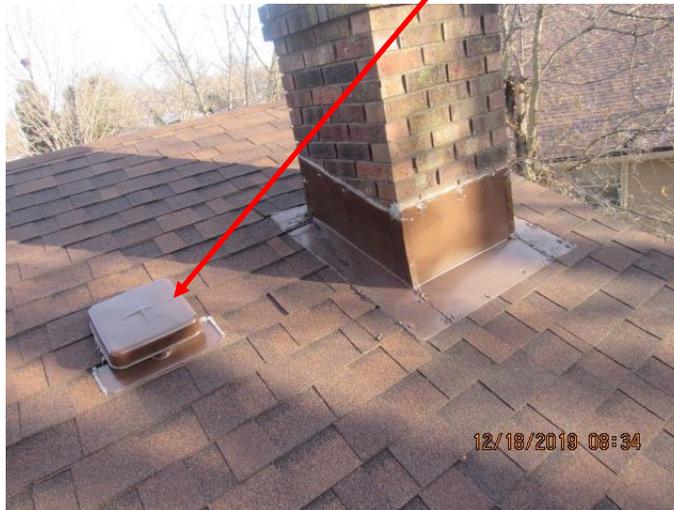
4. The Chimney flashing that has been installed is Apron style. This style of flashing is prone to leaking. It is recommended that Counter flashing over Step flashing be installed if leaks develop or when the roof is re-shingled.

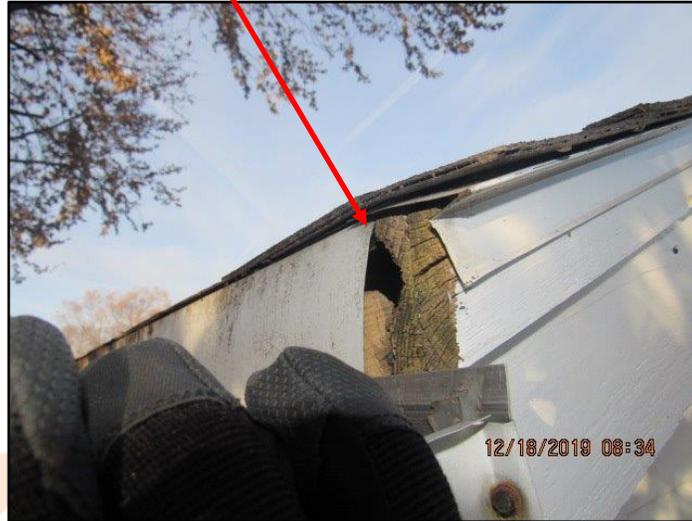
6. The installation of the flashing is incomplete and should be repaired to avoid leaks.

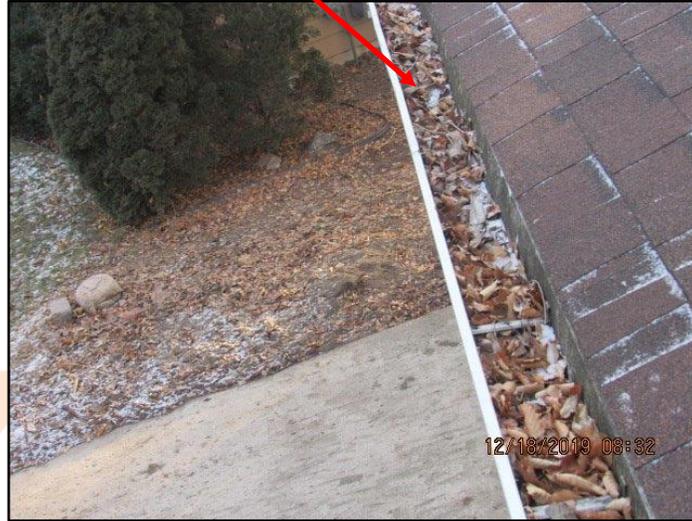
7. The gutters require cleaning to avoid spilling roof runoff around the building a potential source of water entry or water damage.

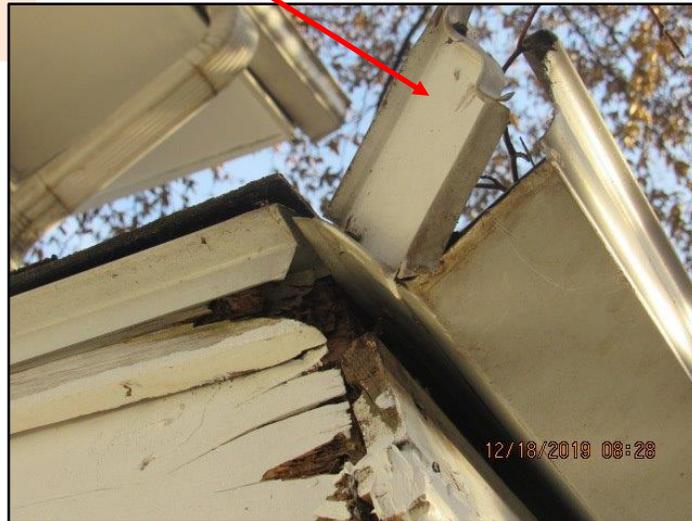
8. Damaged gutters should be repaired or replaced as necessary to avoid spilling roof runoff around the building a potential source of water entry or water damage.

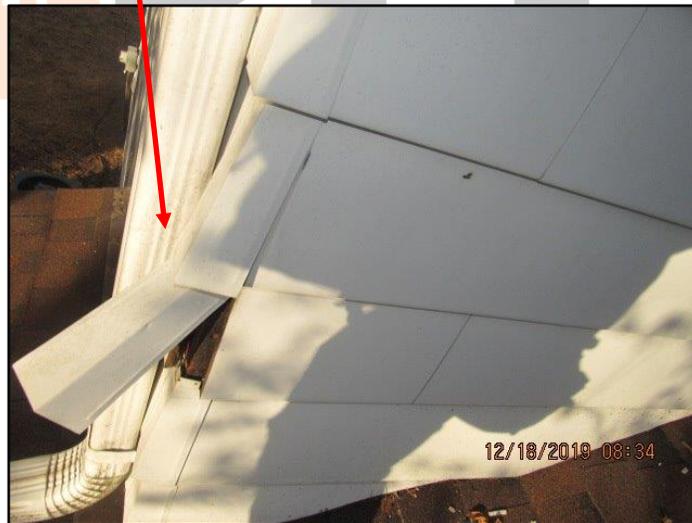
15. The damaged siding should be replaced to avoid water damage.

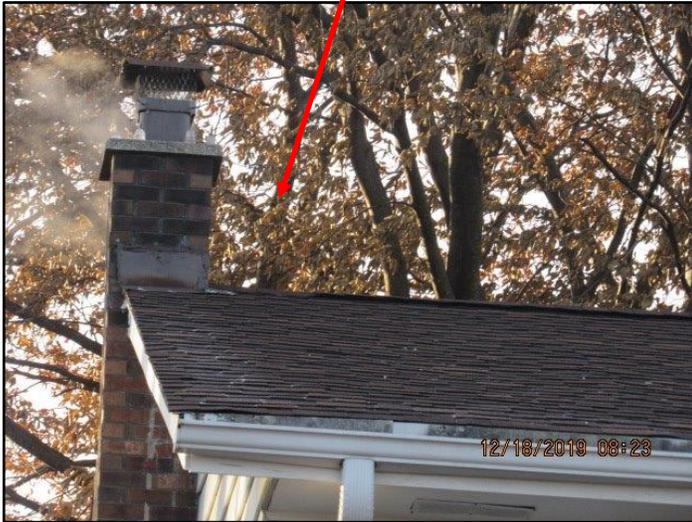
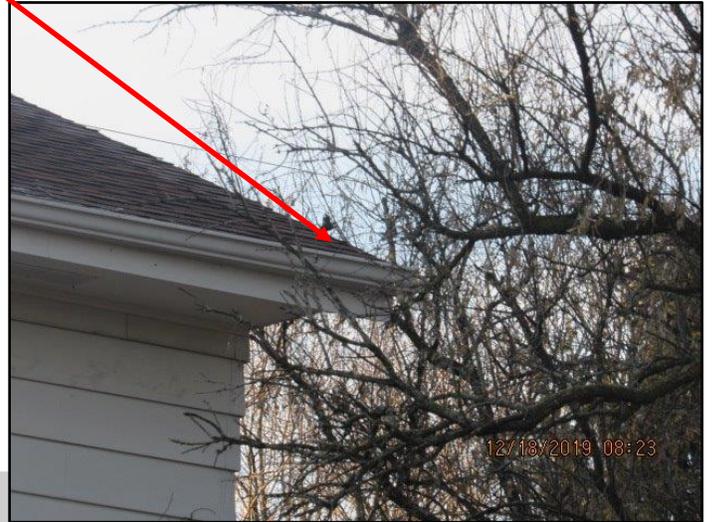
17. The proximity of the tree could disrupt drainage pipes, cause mechanical damage to the exterior of the house, or influence the foundation over time. You should consider removal of the tree.

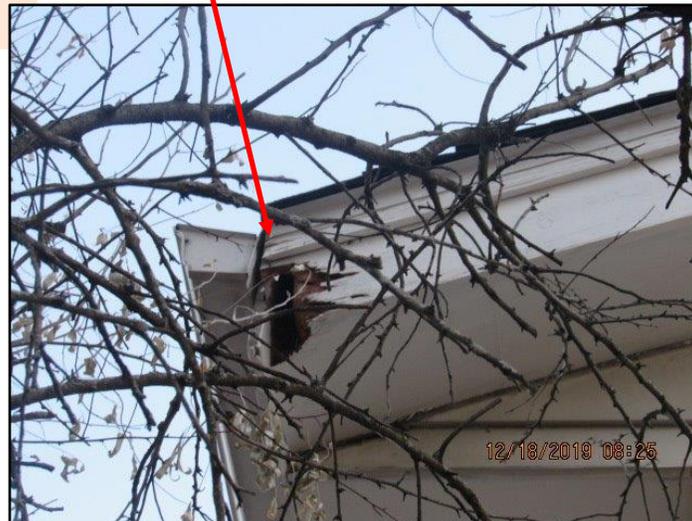
19. The fascia (the wooden board to which the gutter is typically fastened) shows evidence of substantial rot. Repair or replacement is needed.

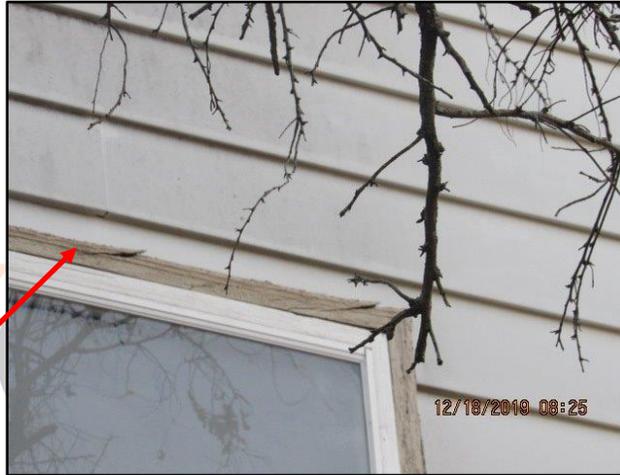
23. Localized evidence of rot was visible at the window sills. Repairs should be undertaken when painting.

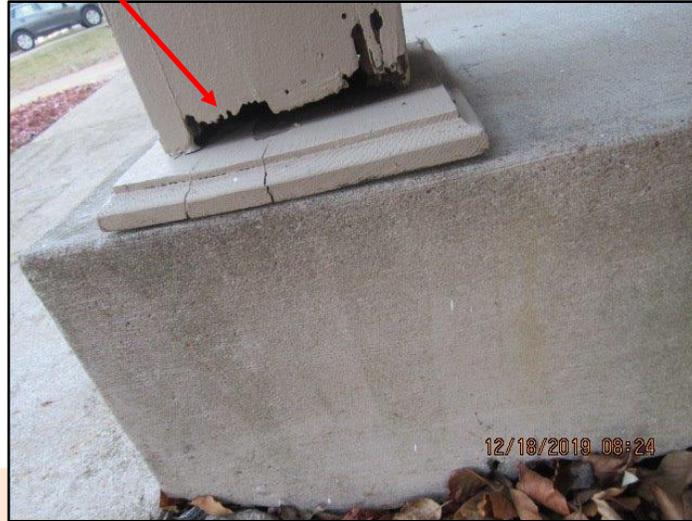
26. The support posts for the deck/porch cover are rotted. They should be replaced to avoid further damage to the structure.

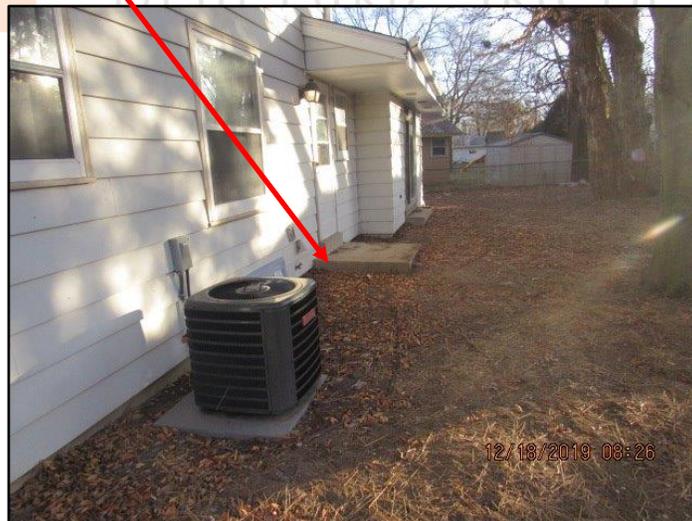
27. The grading should be improved to promote the flow of storm water away from the house. This can often be accomplished by the addition or re-grading of top soil. The ground should slope away from the house at a rate of one inch per foot for at least the first ten feet. At least eight (8) inches of clearance should be maintained between soil level and the bottom of exterior wall siding.

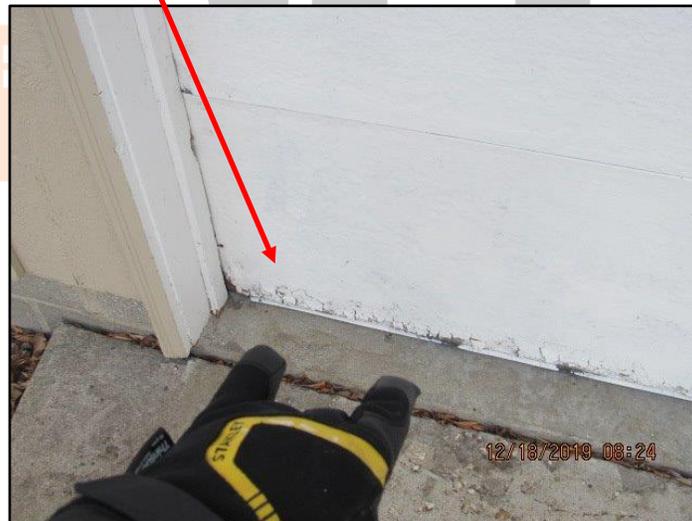
30. The wood overhead garage door shows signs of deterioration/minor rot. Maintenance is needed.

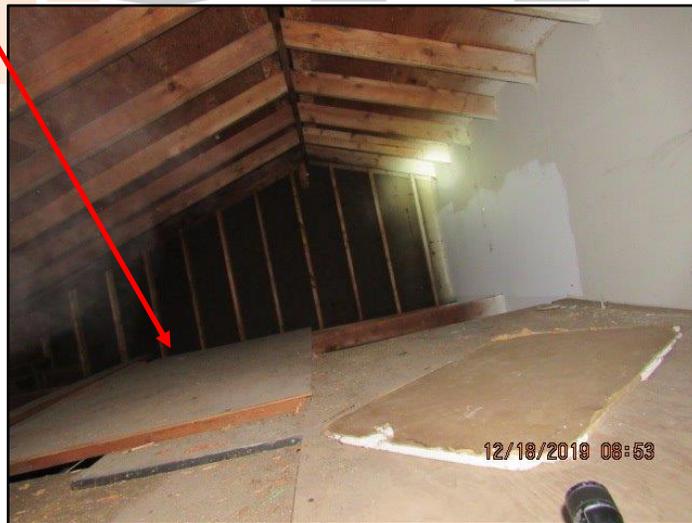
39. The garage rafters should not be used for excessive storage or walking.

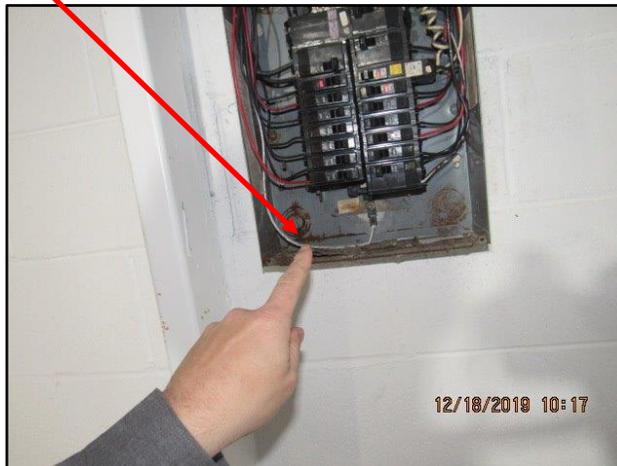
42. The main distribution panel shows evidence of rusting, suggesting the presence of moisture. This area should be monitored. If rusting continues, or if moisture is evident in the vicinity of the panel, an electrician should be consulted.

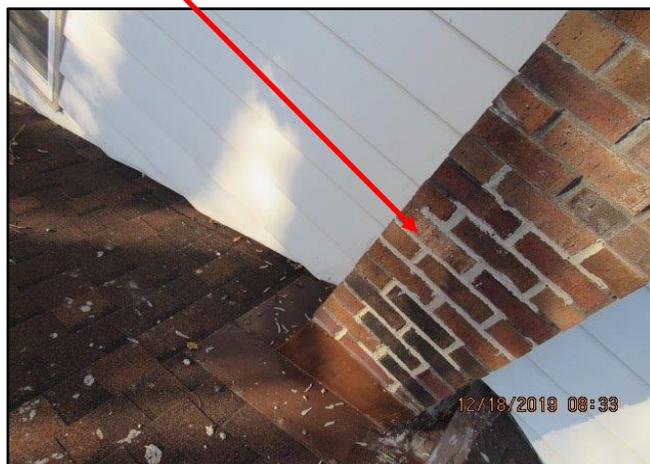
46. The pointing appears to be amateur and could be problematic in the future. I suggest that a mason evaluate for repair.

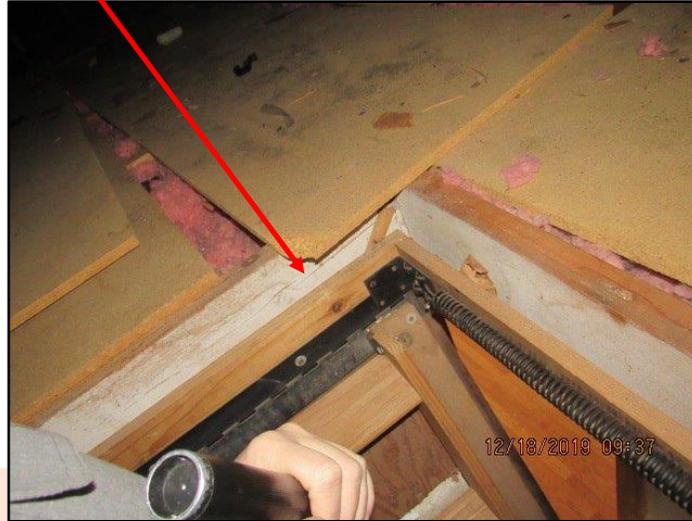
54. The attic access hatch and any penetrations should be air sealed to prevent warm air from the house from entering the attic. Warm air from the house can condense into water vapor after entering a cold attic.

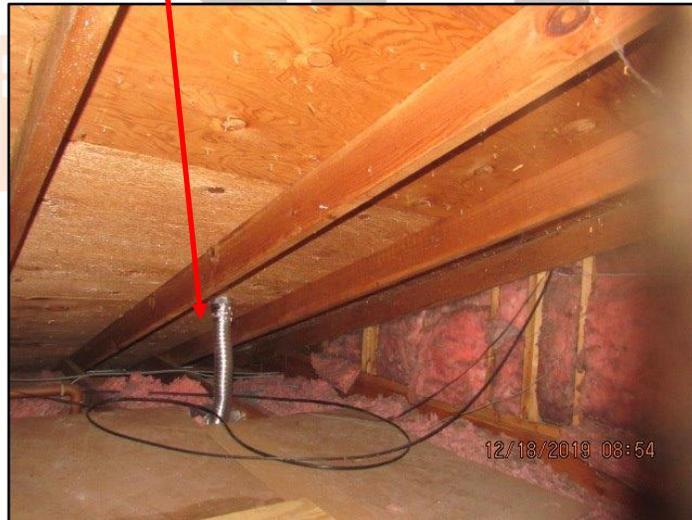
55. Insulation should be provided on exhaust vent pipes.

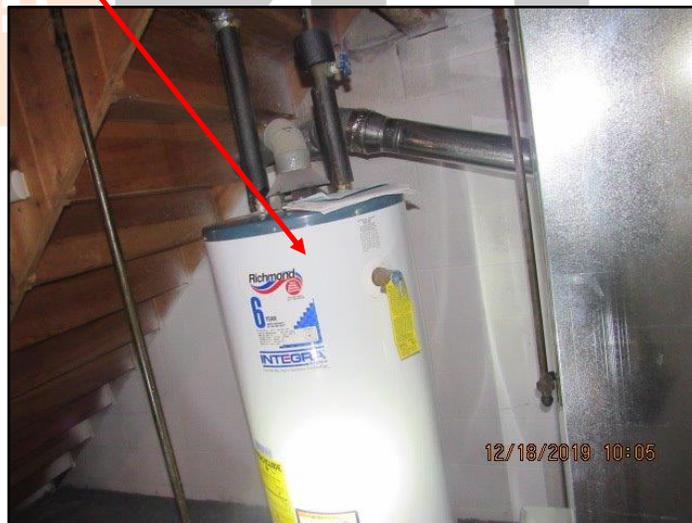
62. The water heater is an old unit that may be approaching the end of its useful life. It would be wise to budget for a new unit. One cannot predict with certainty when replacement will become necessary.

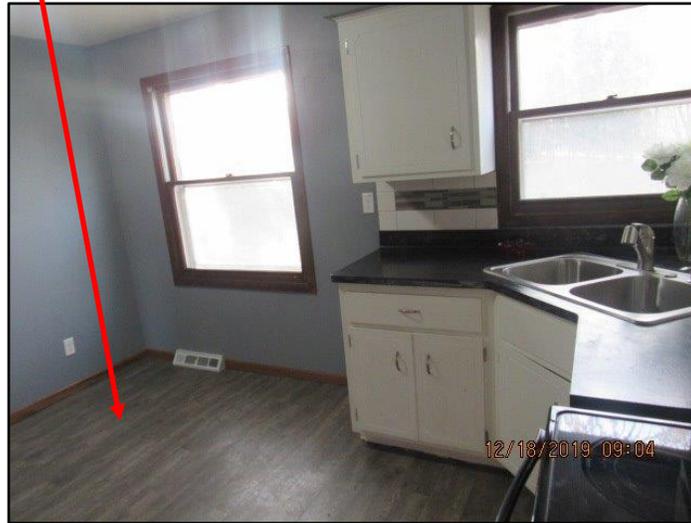
77. Evidence of patching was detected.

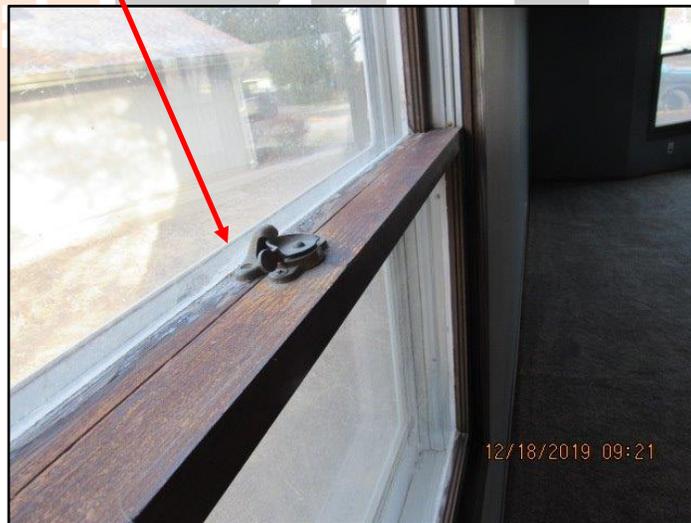
81. The windows are in mild disrepair. This is a common condition that does not necessitate immediate major repair. Trimming and adjustment, hardware improvements, glass and putty repairs would be logical long term improvements. In practice, improvements are usually made on an as needed basis. The most important factor is that the window exteriors are well-maintained to avoid rot or water infiltration.

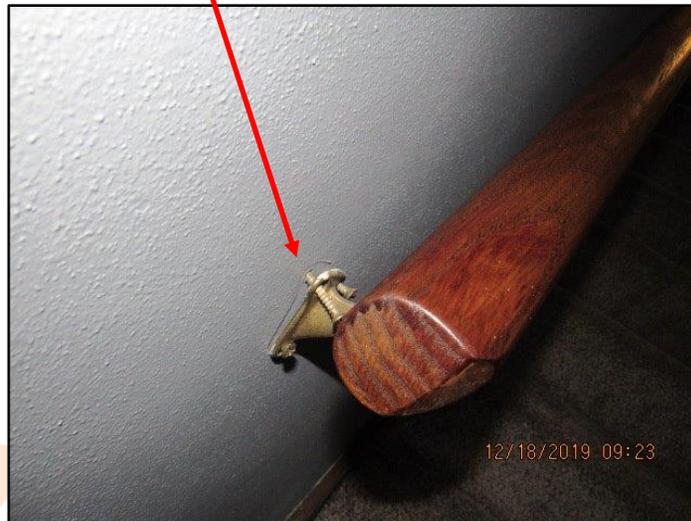
87. Loose stairway handrails should be better secured.
