INSPECTION REPORT

FOR THE PROPERTY AT:
sample

INSPECTION DATE:
June 19, 2025

4 Site Building Inspections Inc

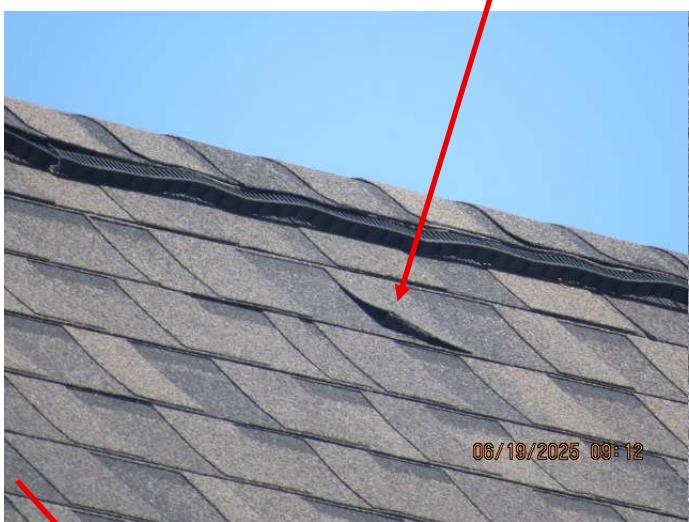
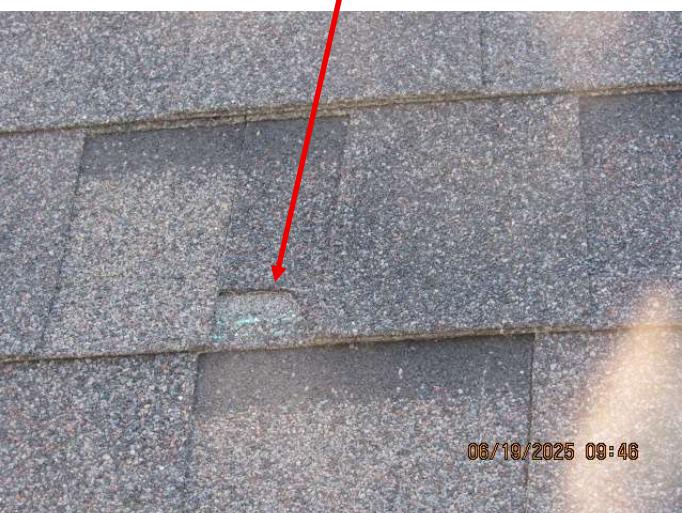
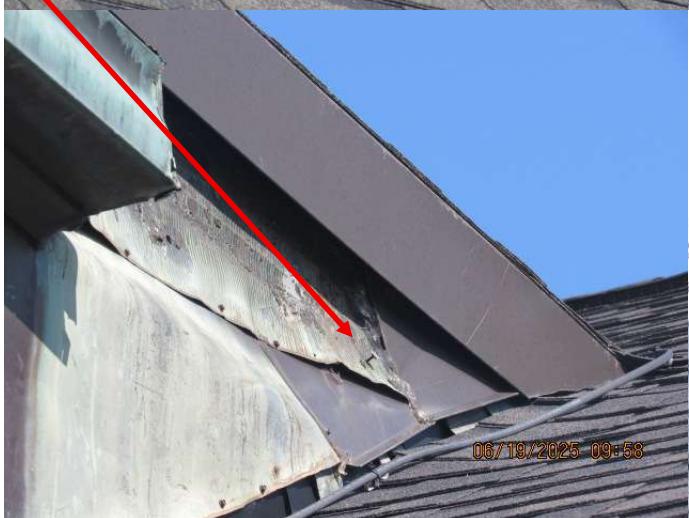
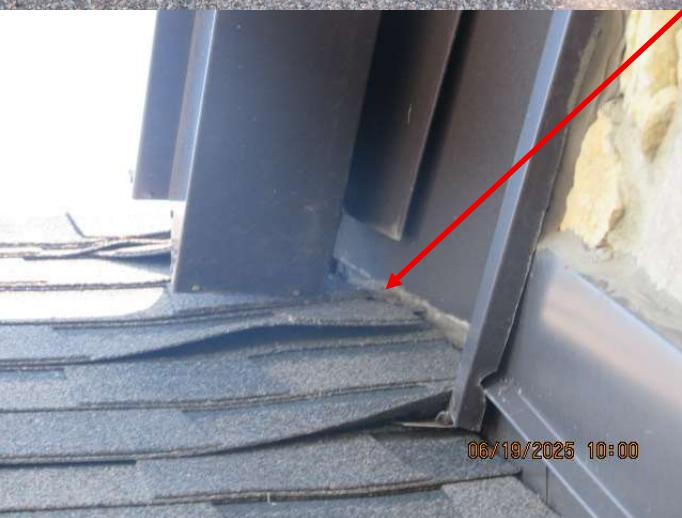
1. The sloped roof is newer. Some roof/wall counter flashing should be better secured at the masonry. Old counter flashing was reused and shows signs of age. A nail pop at the East slope was noted. Buckling/bulging shingles were noted at the roof/wall transitions. Three shingles with damaged corners were noted. The sloped roof may be under warranty and the installer should be consulted to evaluate the roof for repairs.

Task: Repair

Time: within 3-6 months

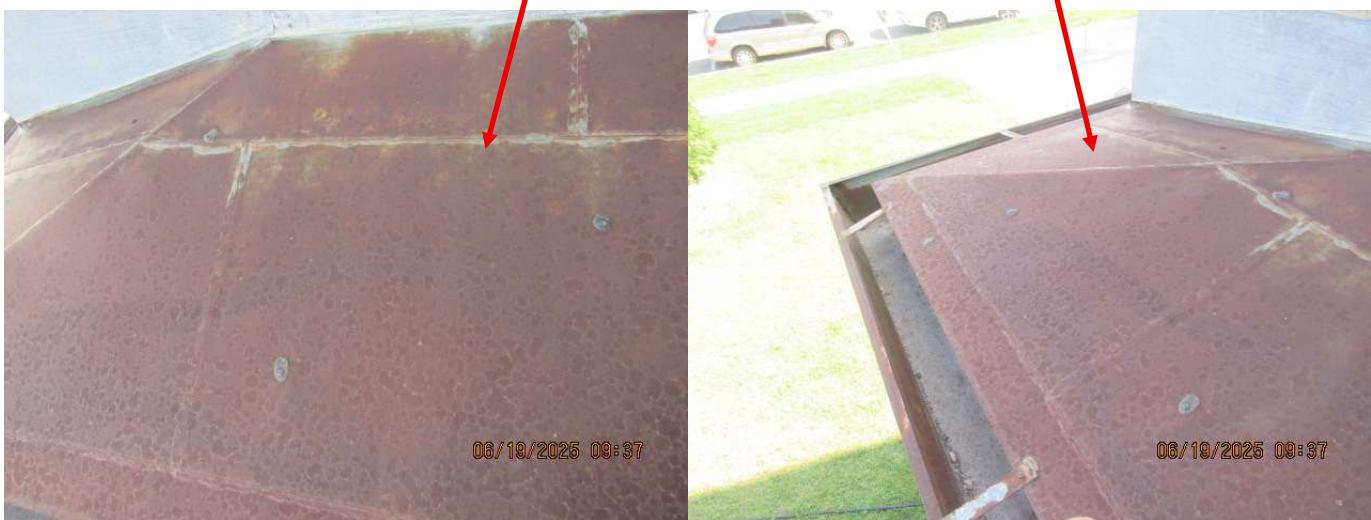
2. The aging metal flat roof components are rusting and need repairs/maintenance. A Roofer should make repairs.

Task: Repair

Time: within 3-6 months

Cost: \$1,500-\$3,000

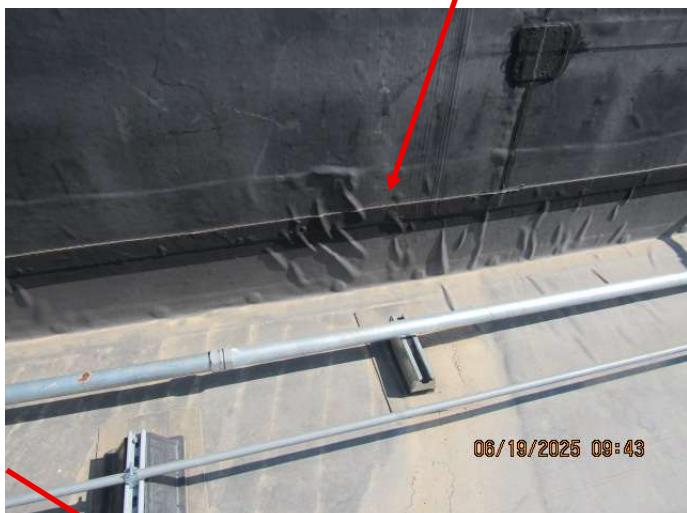
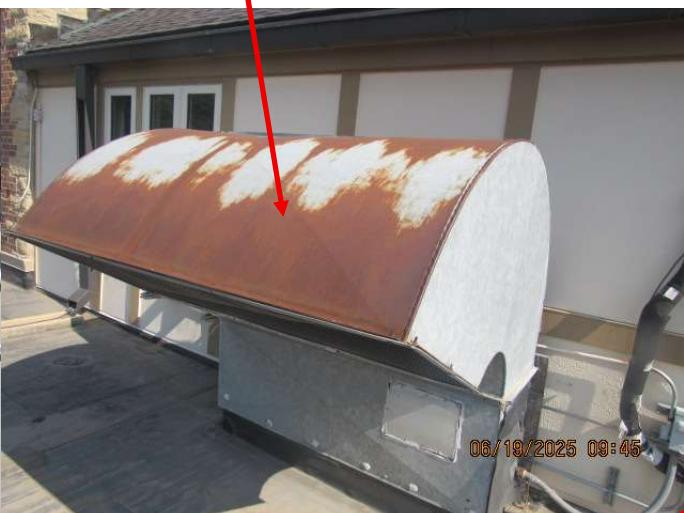
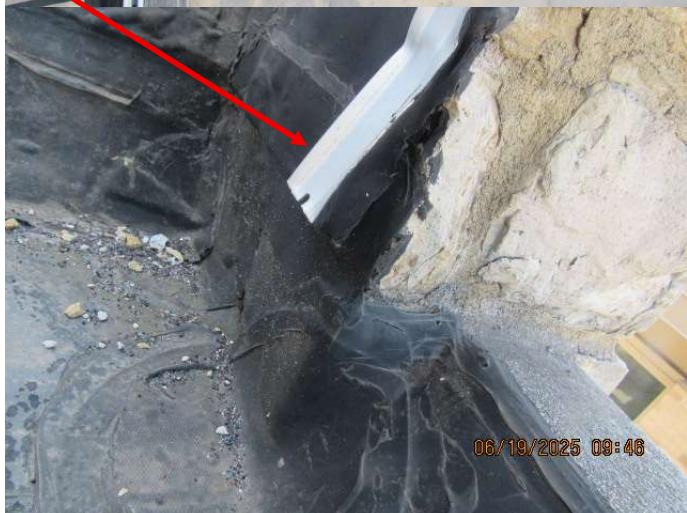
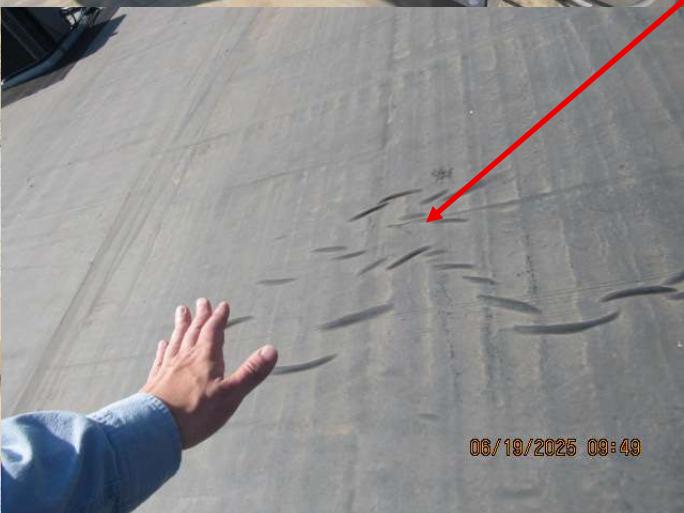
4. The flat roof shows signs of ripples/wrinkles. Loose transitions at walls. A roof drain grate is missing. Debris should be removed at the roof drain. Roof vents are rusted or have damage. A Certified Roofer should evaluate the flat roof, flashings and roof vents for repairs.

Location: Various**Task:** Repair**Time:** Within 1 year**Cost:** \$3,000-\$5,000

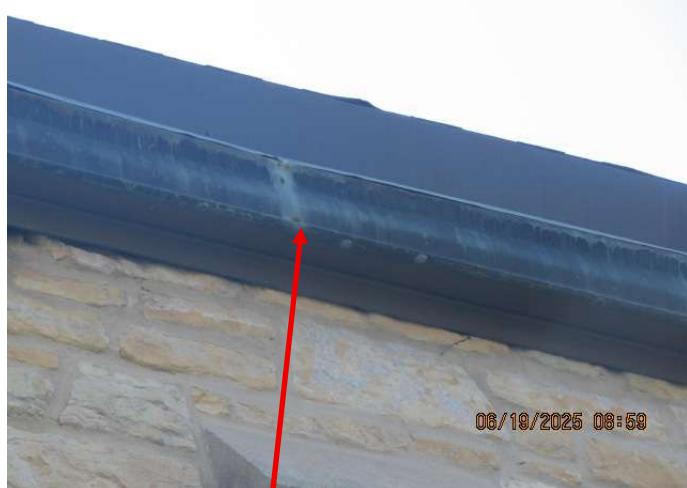
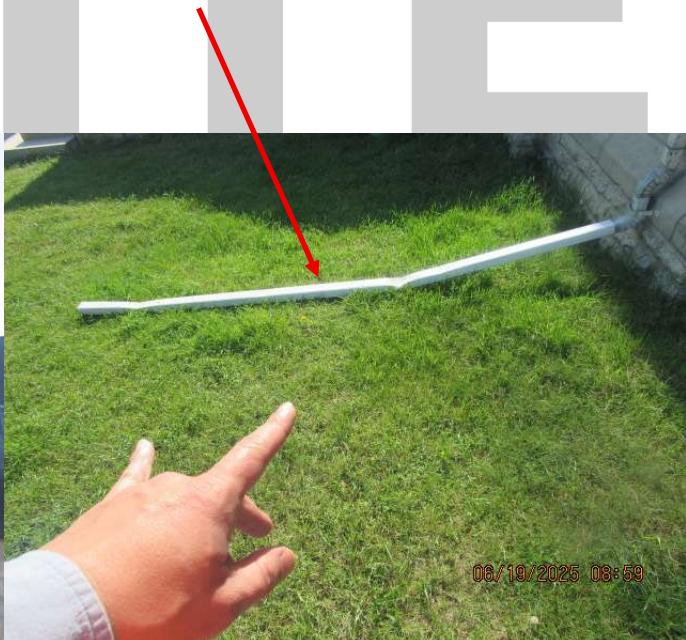
6. Loose or damaged downspouts and extensions should be repaired promptly.

Location: Various**Task:** Repair**Time:** Discretionary

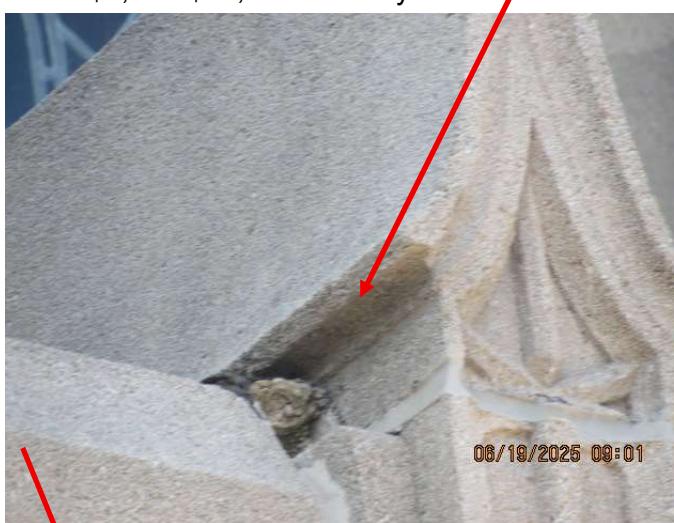
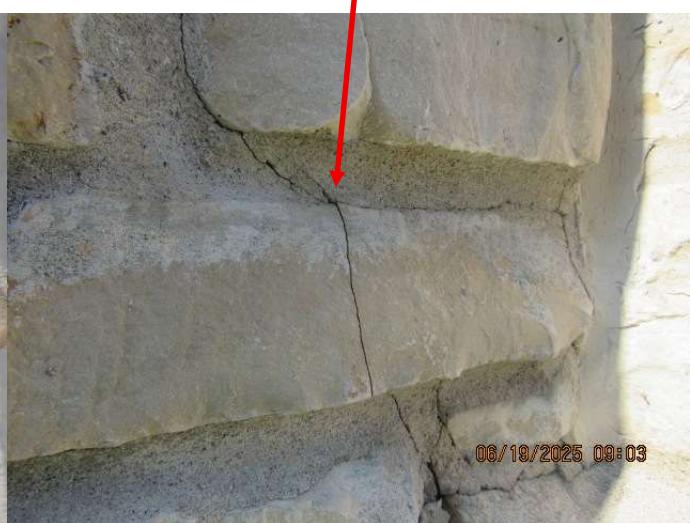
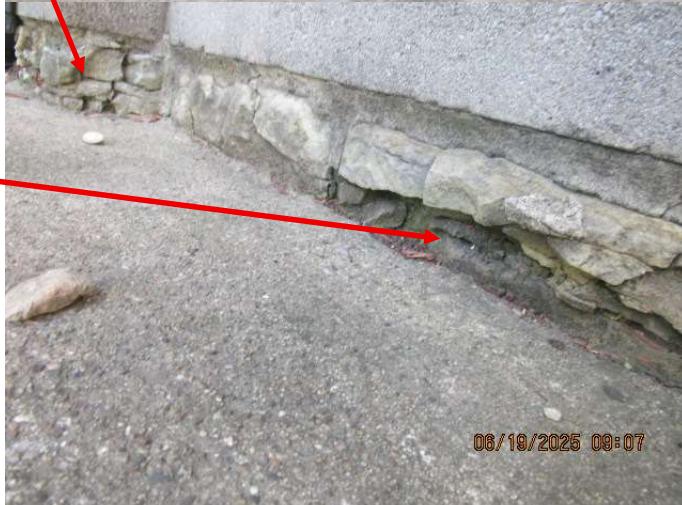
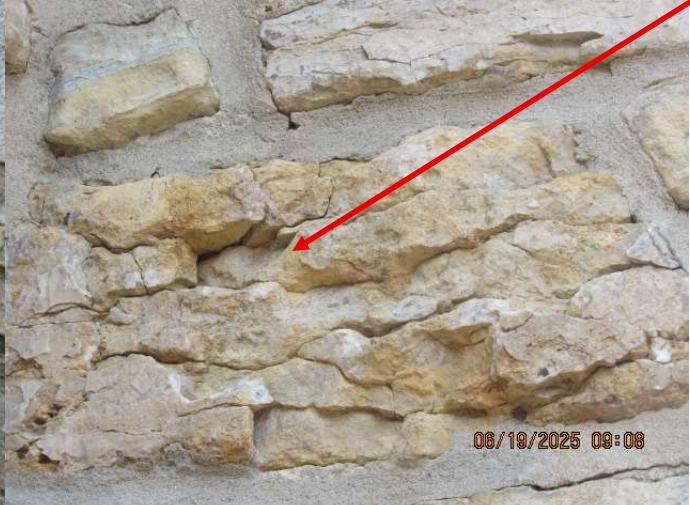
10. Some stone/masonry repairs were taking place at the time of inspection. A plan/budget should be put in place for annual inspection, maintenance, repairs of the stone/masonry exterior. There are various areas where some tuckpointing and stone repairs are needed. Some stone shows signs of crumbling and repairs could negatively influence other stones in the area leading to more extensive repairs.

Location: Various**Task:** Repair**Time:** Annually**Cost:** \$8,000-\$10,000 annually

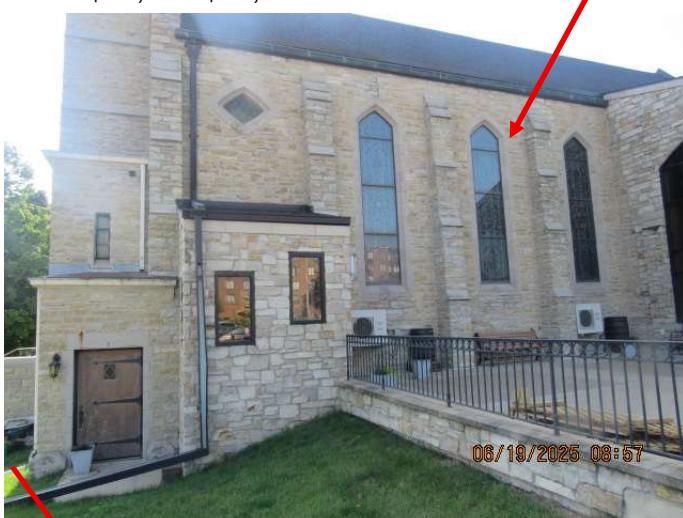
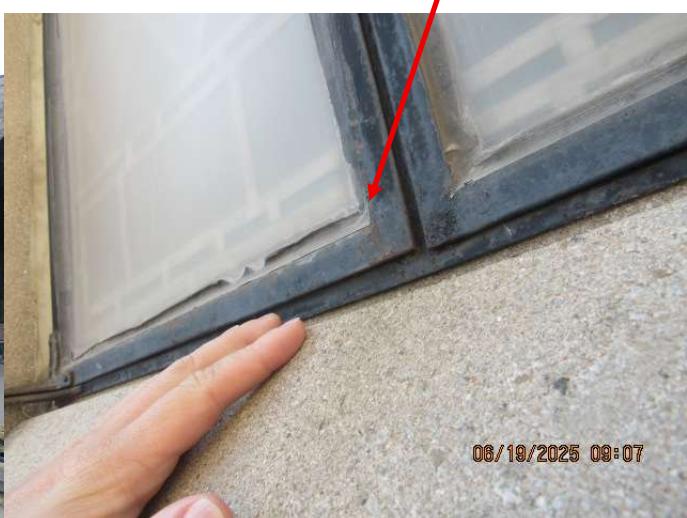
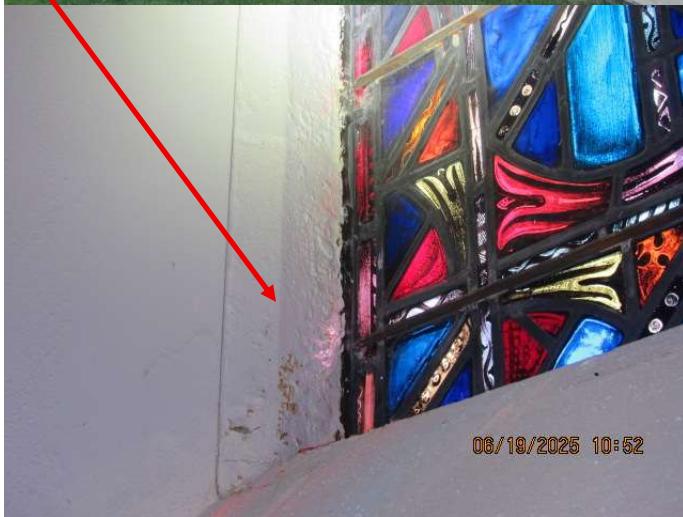
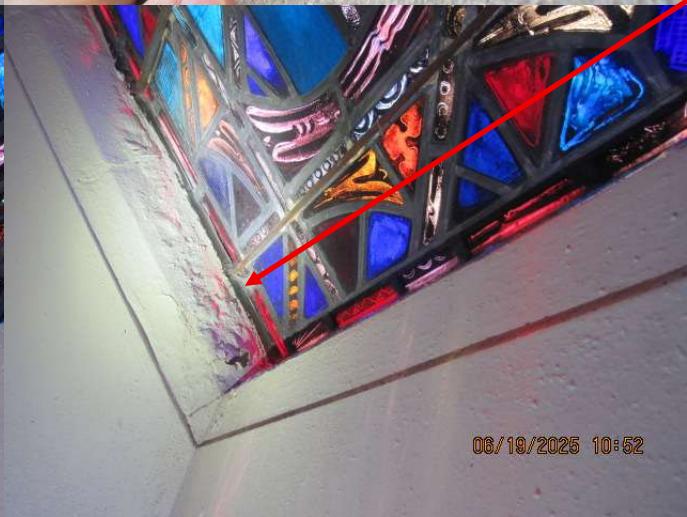
13. Various windows shows signs of age. Some seals have failed, caulking is poor, putty is deteriorated, framing shows signs of rust. Water intrusion was noted at some windows at both West entrances. A window contractor should be consulted to evaluate the exterior windows for maintenance/repairs.

Task: Repair Further Evaluation

Time: 1-3 years

Cost: \$35,000-\$45,000

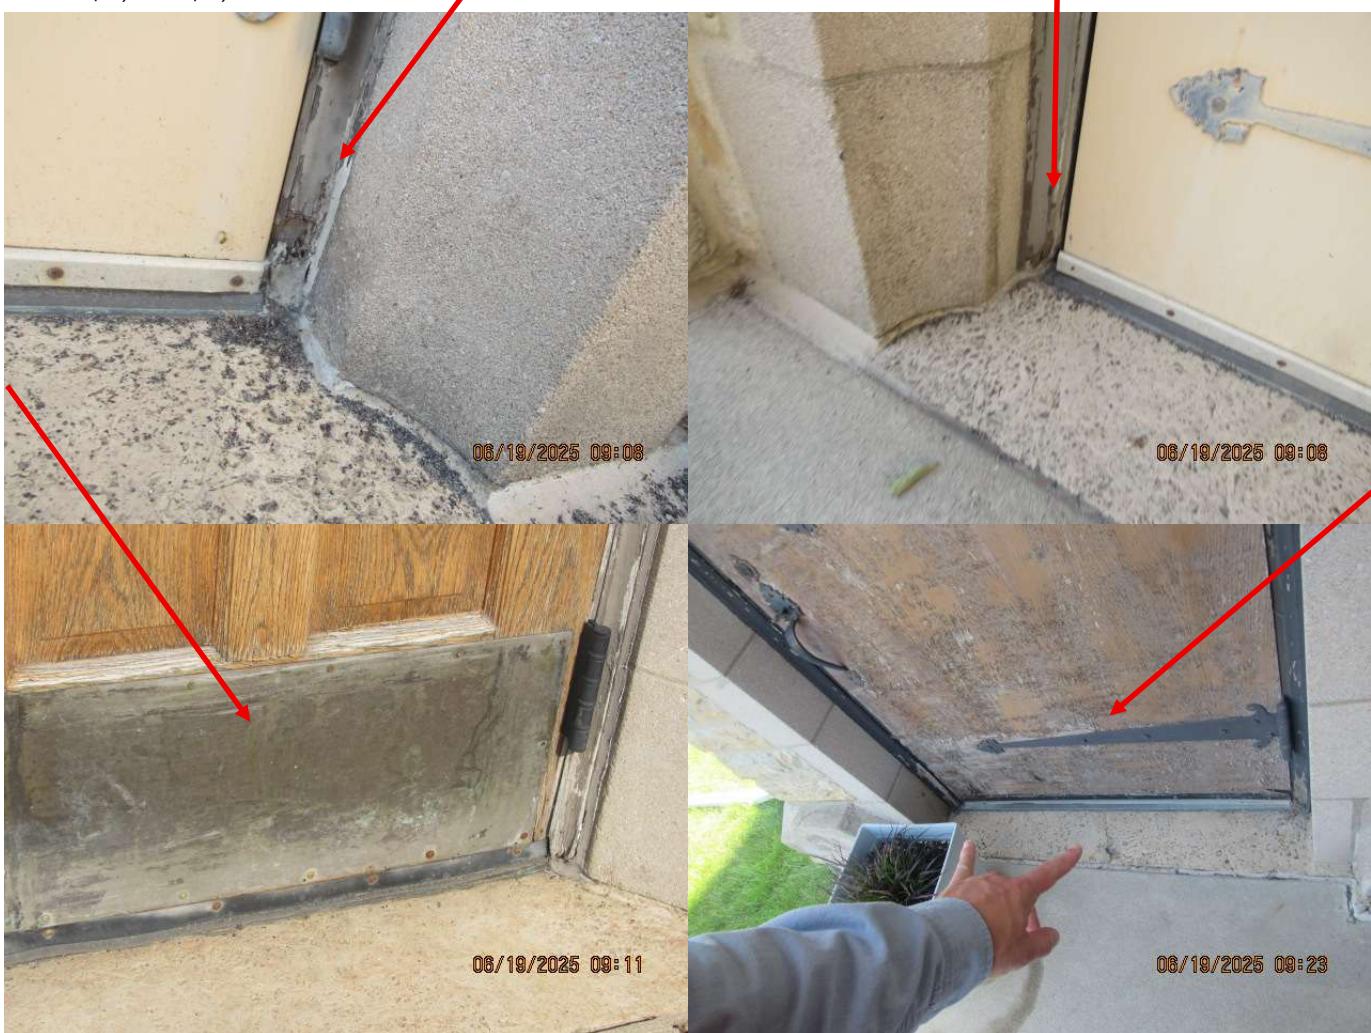
16. Exterior wood doors and trim on the original building show signs of age/wearing. Repairs/maintenance to the doors will help extend the life of the doors.

Task: Repair

Time: Within 1 year

Cost: \$3,000-\$5,000

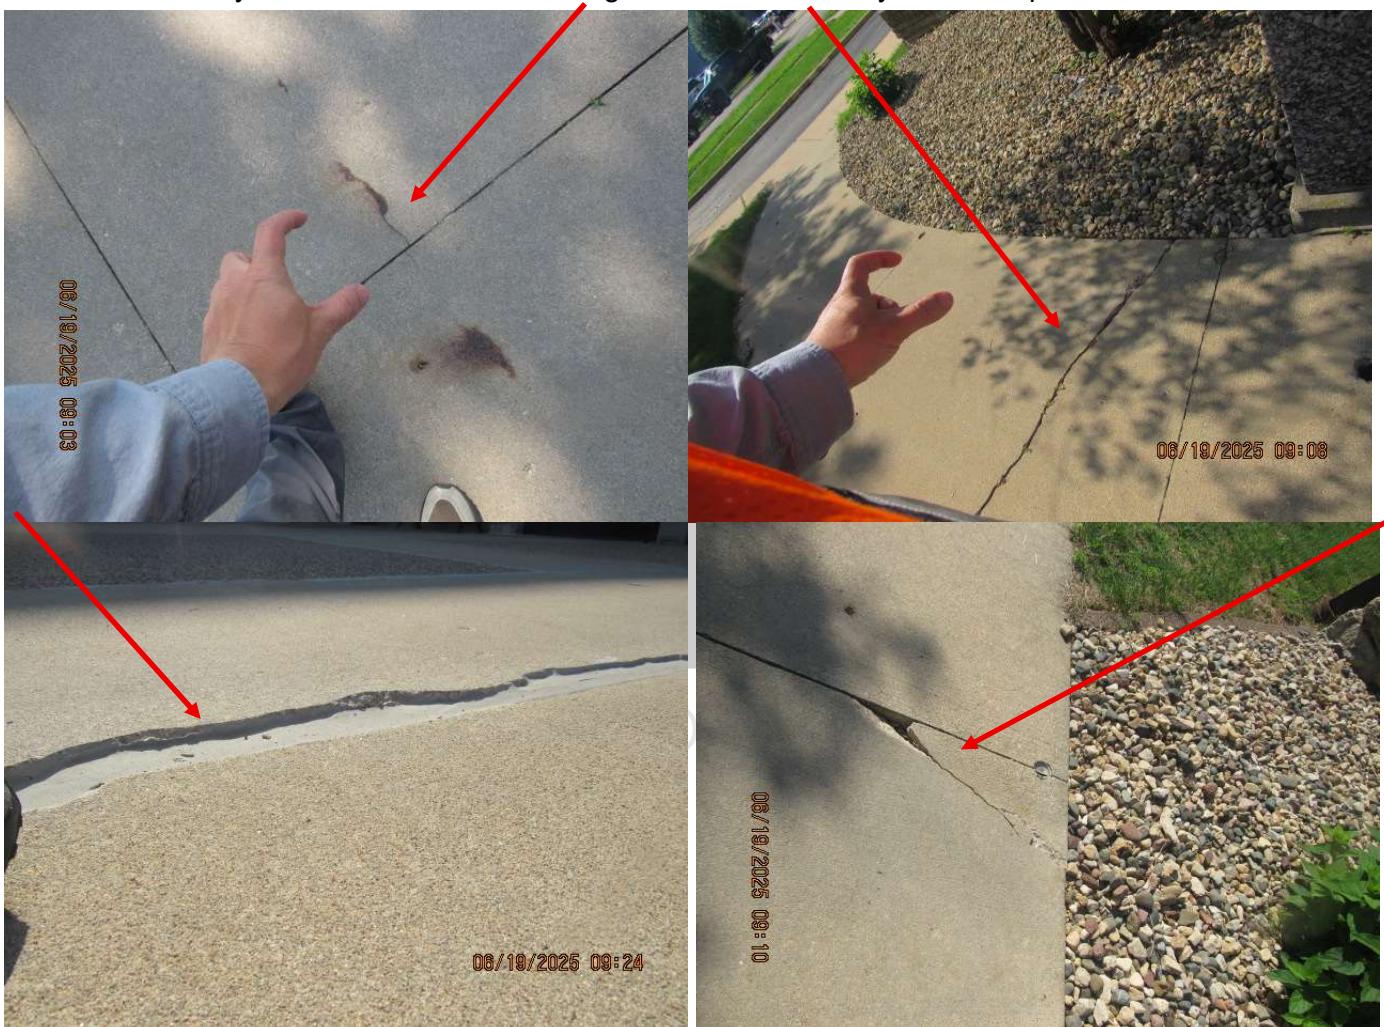
Damaged concrete walkways needs repairs.

Location: South**Task:** Repair**Time:** Immediately

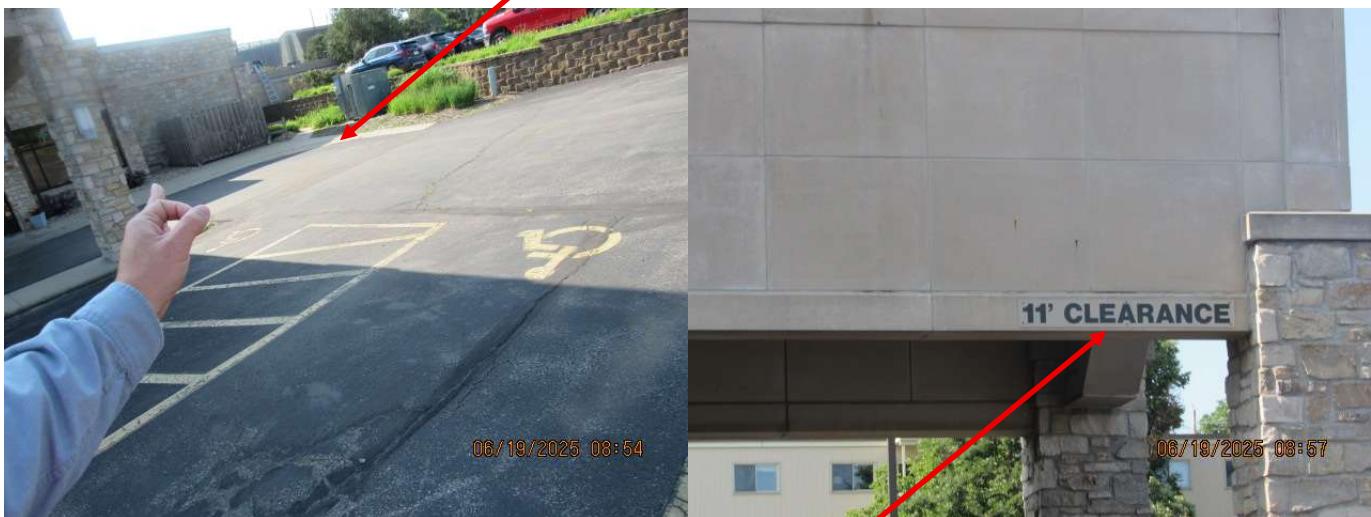
22. The West parking lot and East driveway is in need of patching and sealing. Abandoned signage penetrations should be removed. Damaged curbing should be repaired. Curb height is too high near the patio. Parking lot lines will need to be painted as part of the parking to improvements.

Time: 8-10 years

Cost: \$120,000-\$140,000

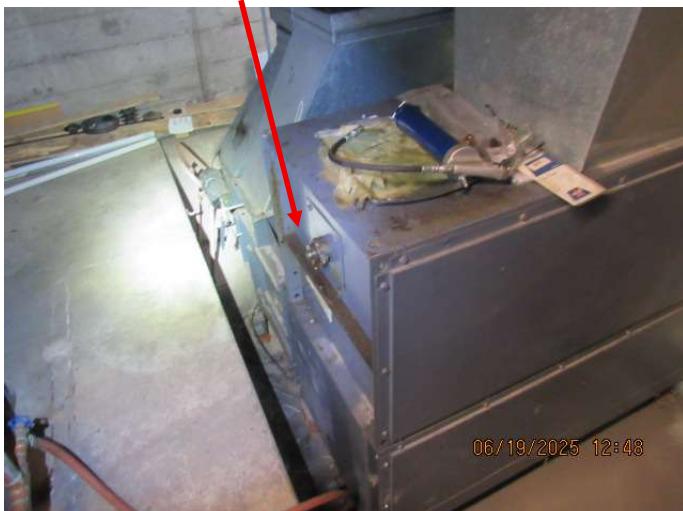
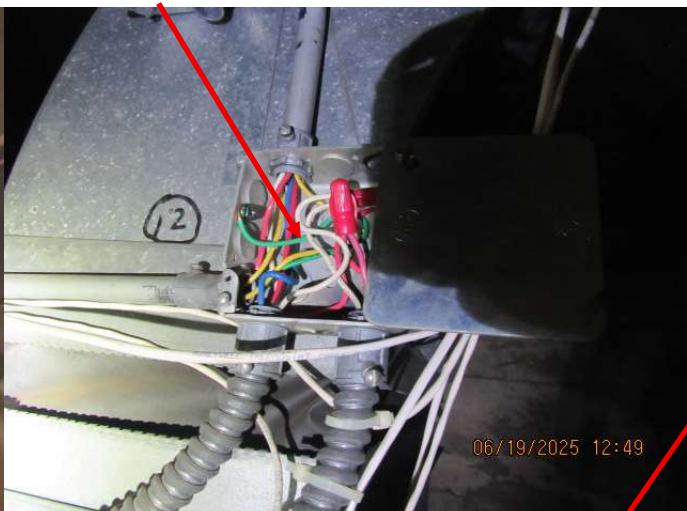
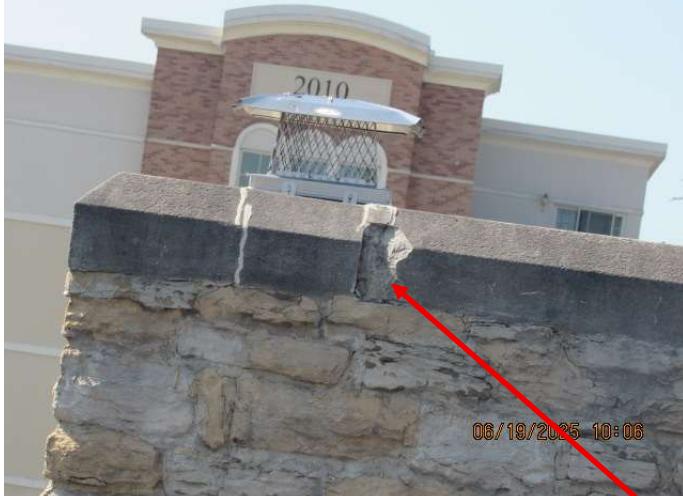
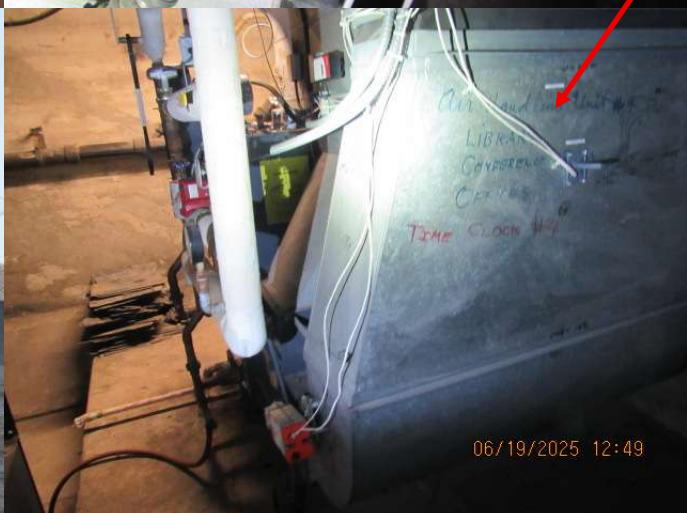
47. The four air handlers are past life expectancy. On-going service/maintenance will help extend the life of the units. A budget should be set aside for replacement.

Junction box should be capped in air handler room

Cost: \$150,000-\$175,000

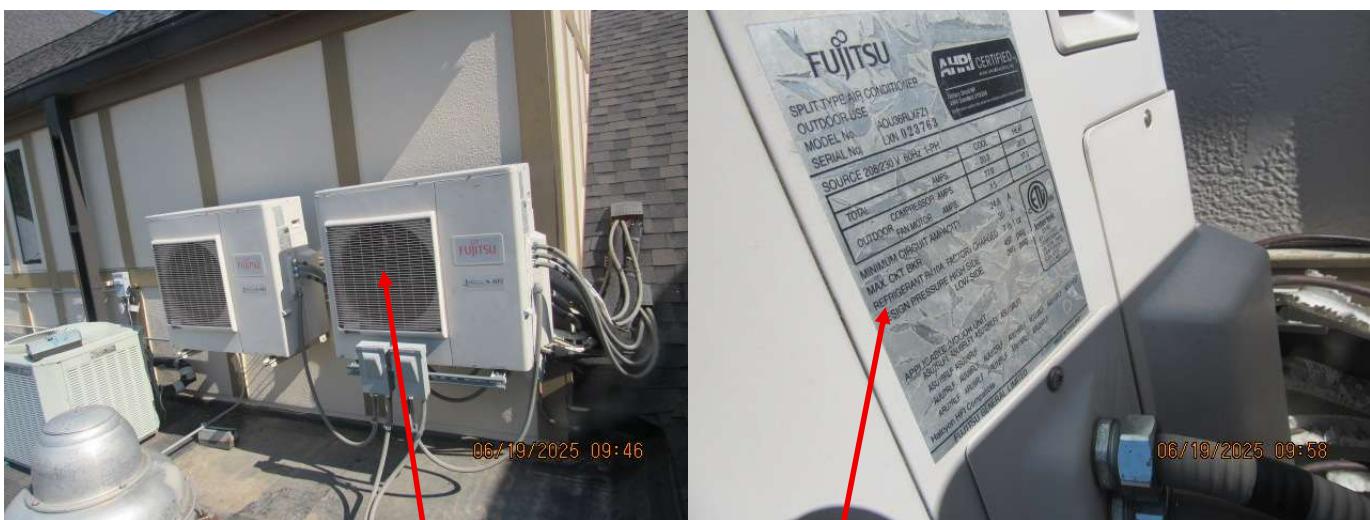
52. Some central air units provided below average cooling returns when tested. The units have damaged insulation on coolant lines and some damaged wiring conduit should be repaired on the roof. A HVAC contractor should perform service to these units.

Time: 10 years

Cost: \$30,000-\$35,000

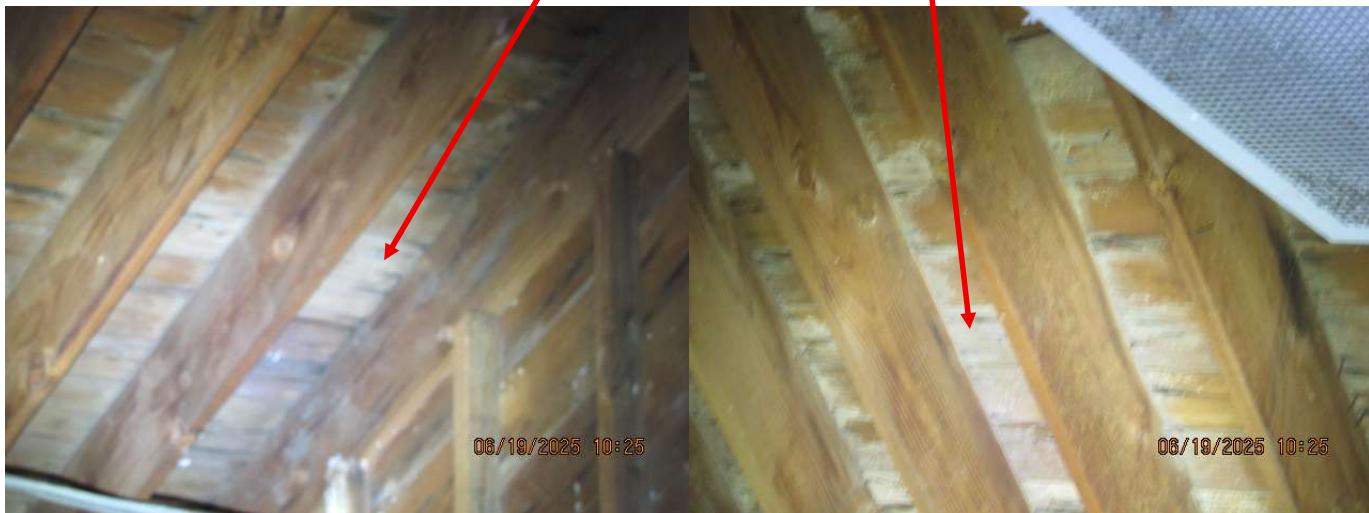
57. Evidence of a mold like/bacteria growth was observed. I suggest that a mold or bacteria specialist evaluate for treatment.

Location: Attic**Task:** Repair Further Evaluation**Time:** Discretionary

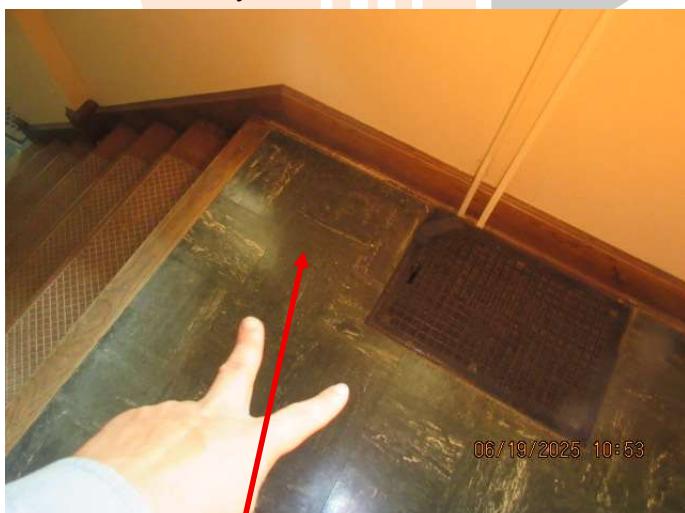
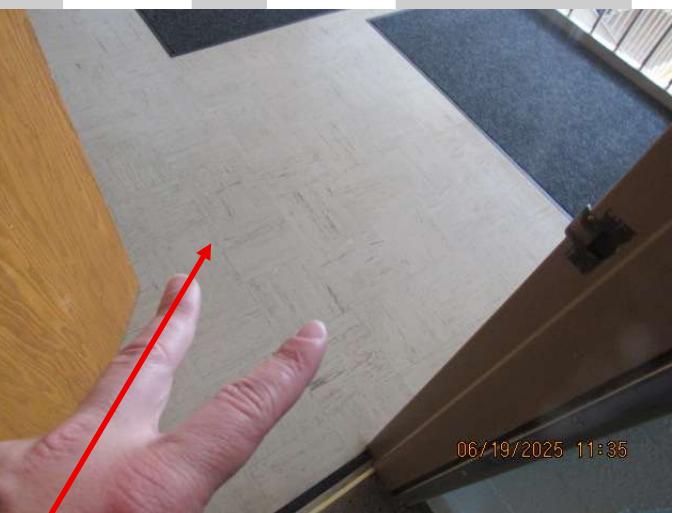
69. Broken West entry tiles should be repaired.

Task: Repair

Time: Immediately

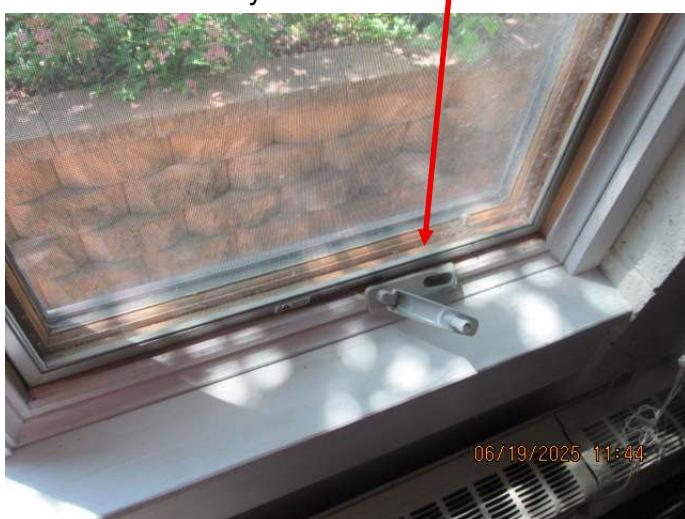
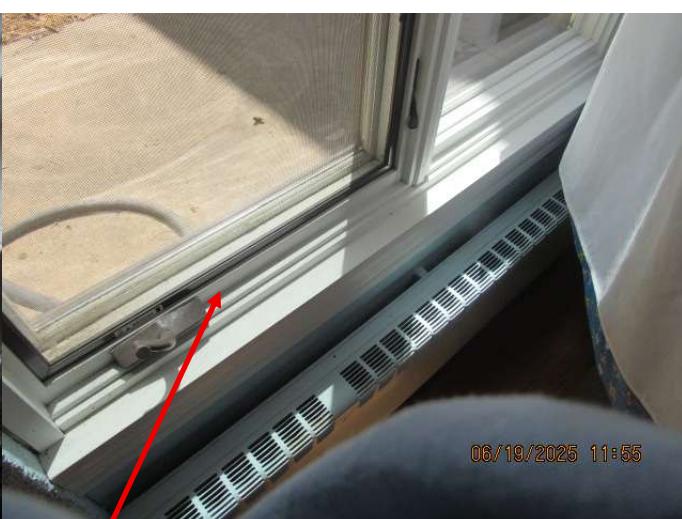
71. Some casement cranks need adjustments/minor repairs.

Location: Various**Task:** Improve**Time:** Discretionary
