# Inspection Report

Milwaukee WI 53228

December 18, 2019

## 4 Site Building Inspections LLC

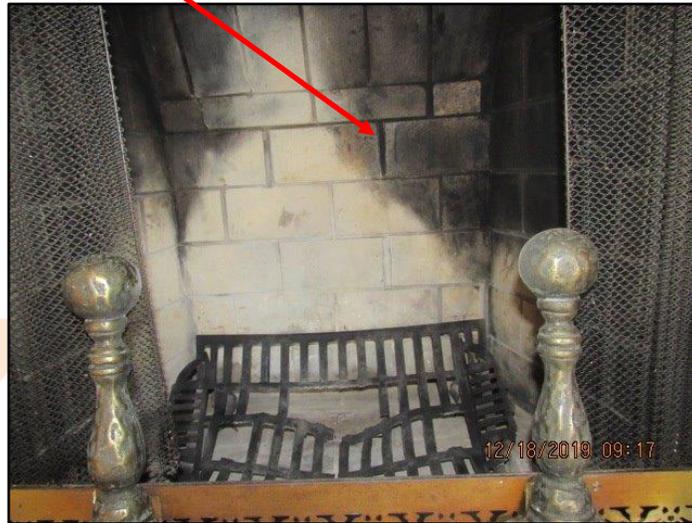
49. The fireplace damper requires repair.

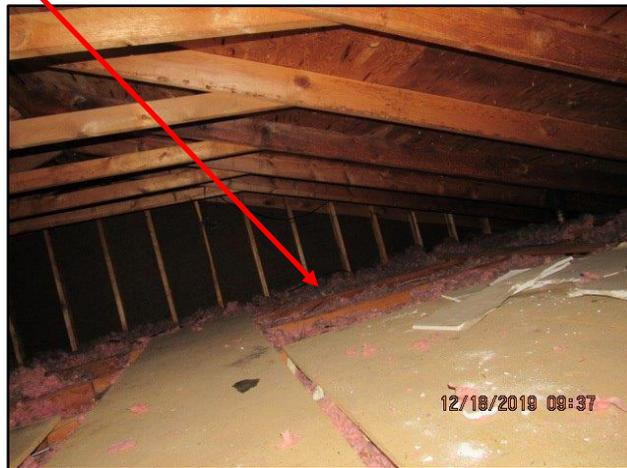
54. The attic access hatch and any penetrations should be air sealed to prevent warm air from the house from entering the attic. Warm air from the house can condense into water vapor after entering a cold attic.

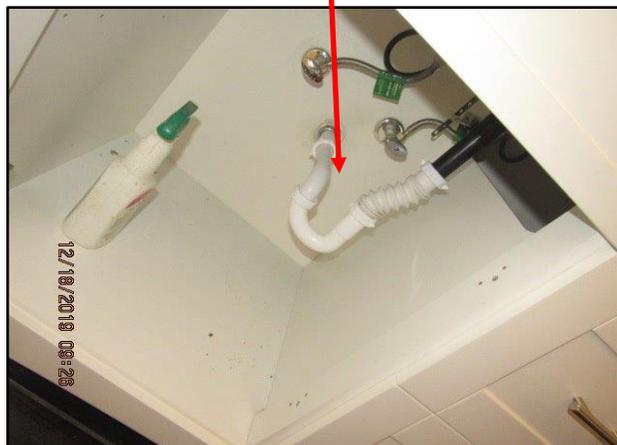
69. The waste piping should be better supported.

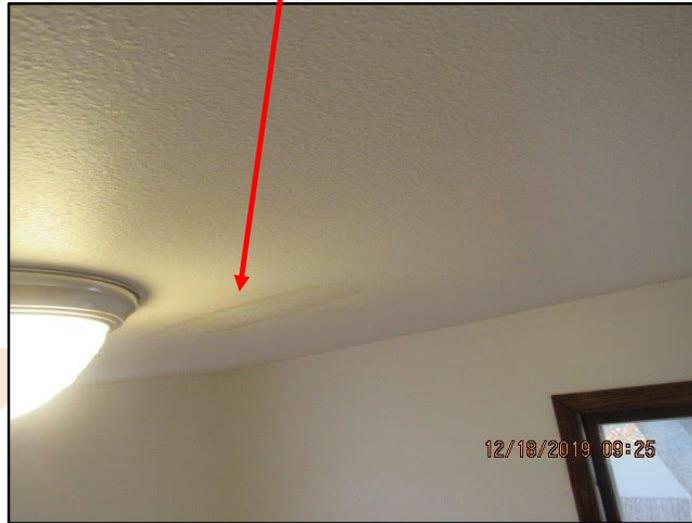
77. Evidence of patching was detected.
