INSPECTION REPORT

FOR THE PROPERTY AT:
sample

INSPECTION DATE:
June 19, 2025

4 Site Building Inspections Inc

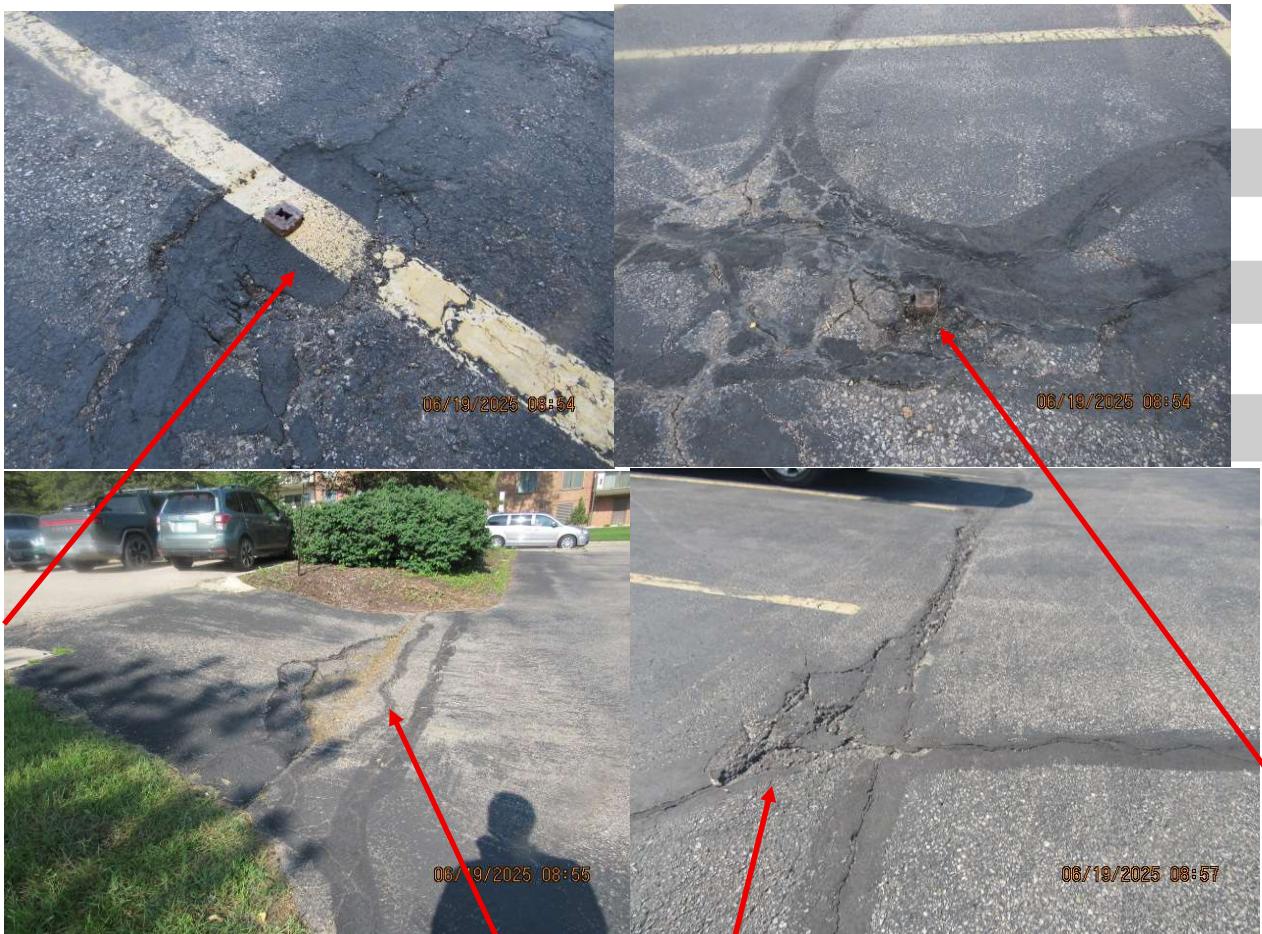
Landscaping\Driveway

22. The West parking lot and East driveway is in need of patching and sealing. Abandoned signage penetrations should be removed. Damaged curbing should be repaired. Curb height is too high near the patio. Parking lot lines will need to be painted as part of the parking to improvements.

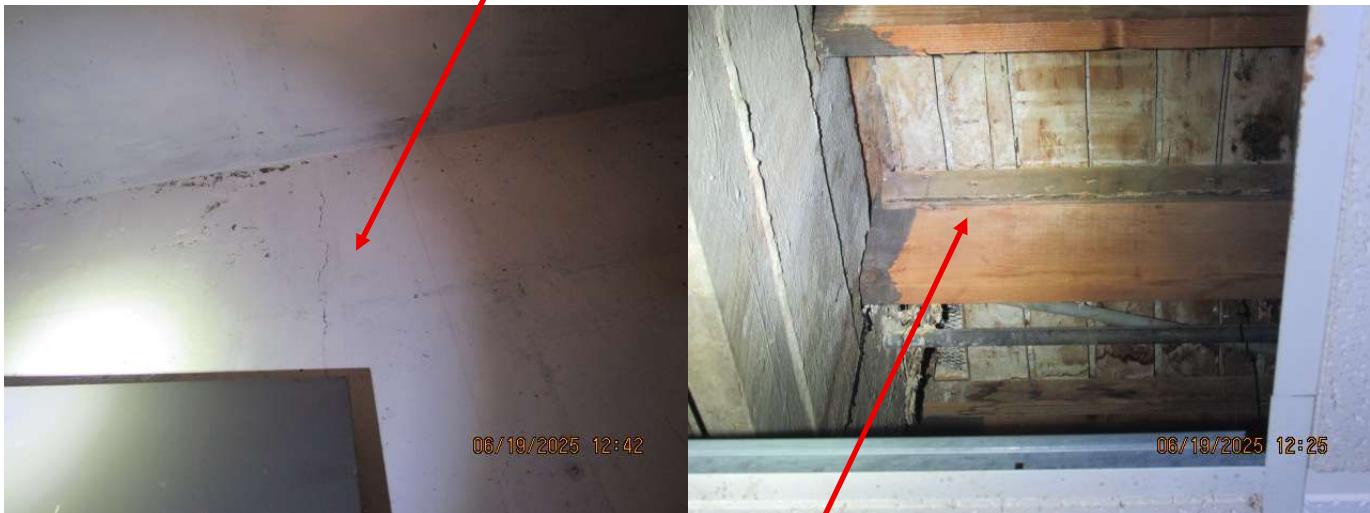
Floors\Joists

29. Some floor joists show evidence of past water damage. The area was dry at the time of inspection.

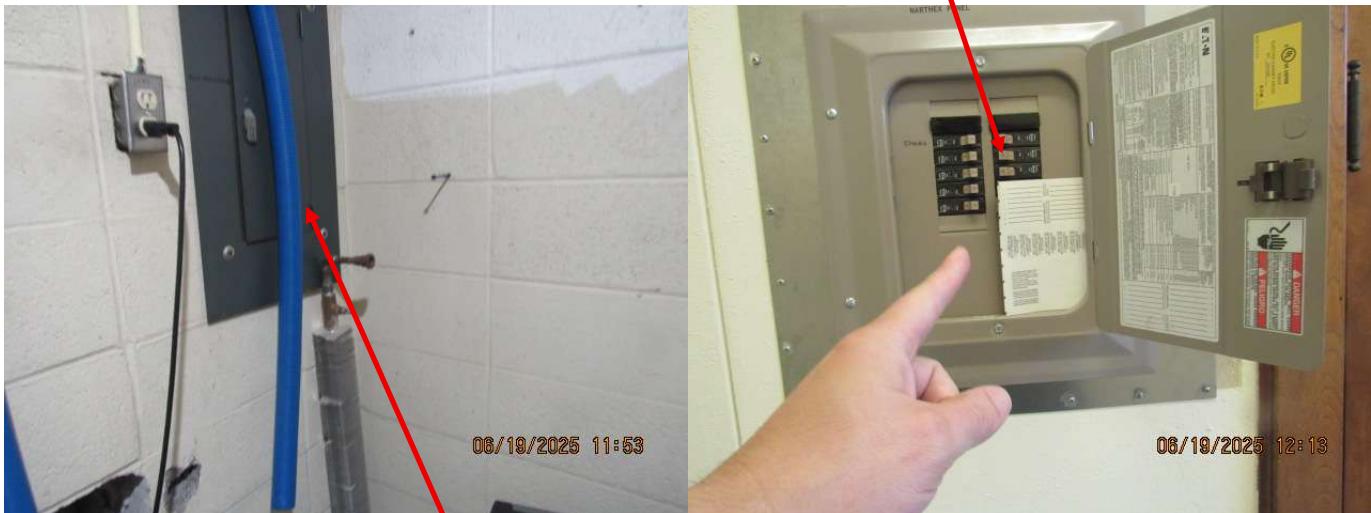
31. There should be a workspace in front of each electrical panel that is 3 feet deep and 2.5 feet wide. There should be nothing in front of each panel.

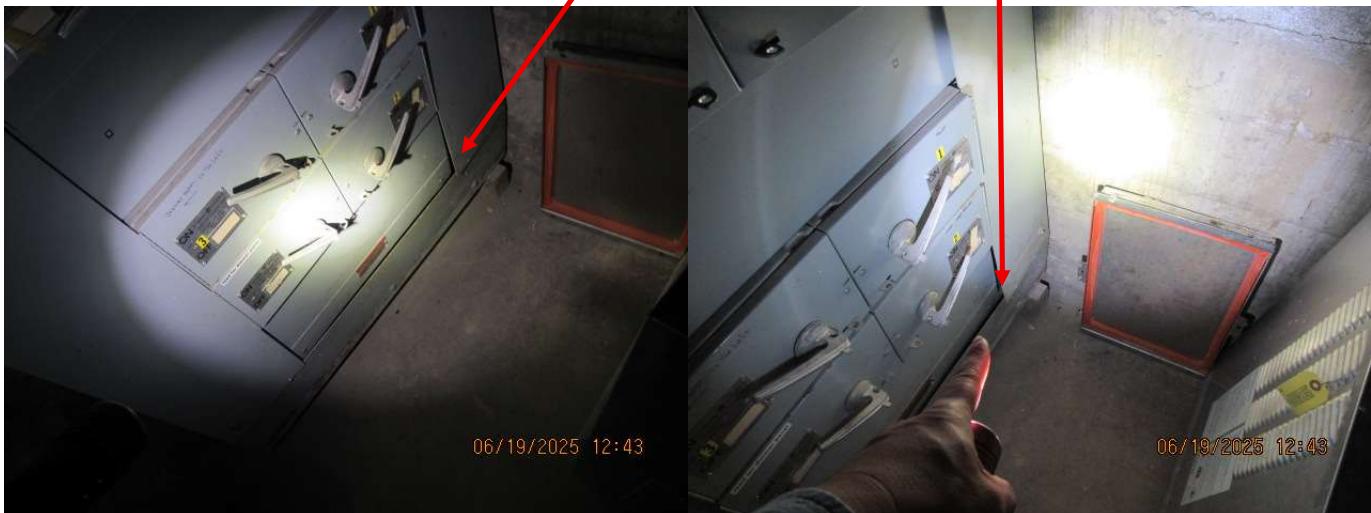
Distribution system\Wiring (wires) - installation

33. Improper electrical connections should be repaired. All electrical connections should be made inside junction boxes fitted with cover plates

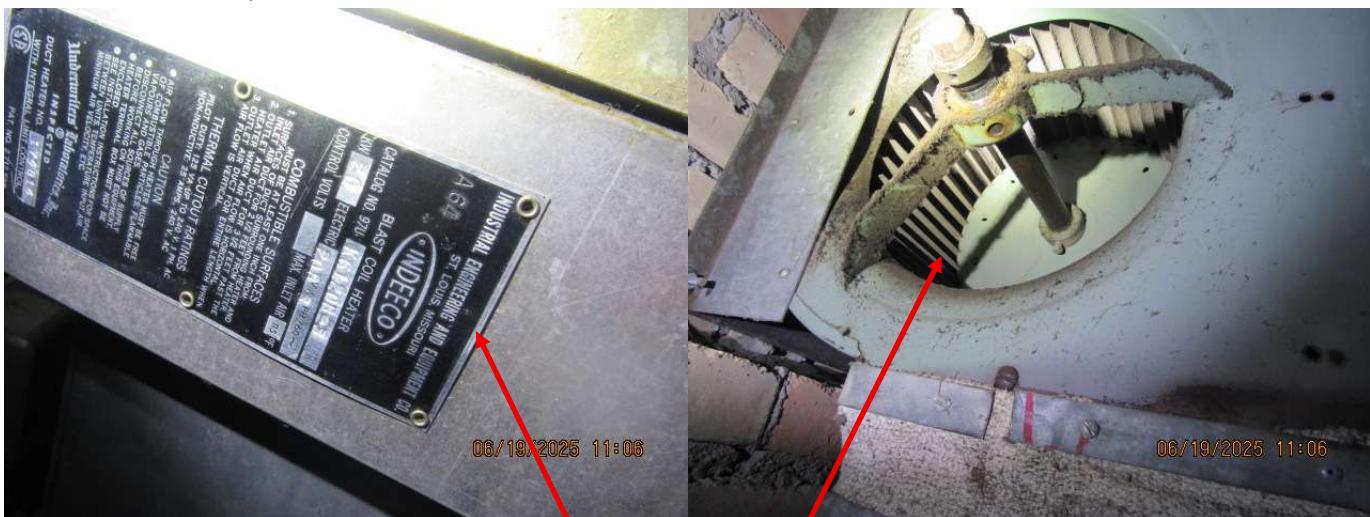
Auxiliary heat\Electric radiant

50. Ancillary Electric heater is past life expectancy. Replacement will be needed in the near future

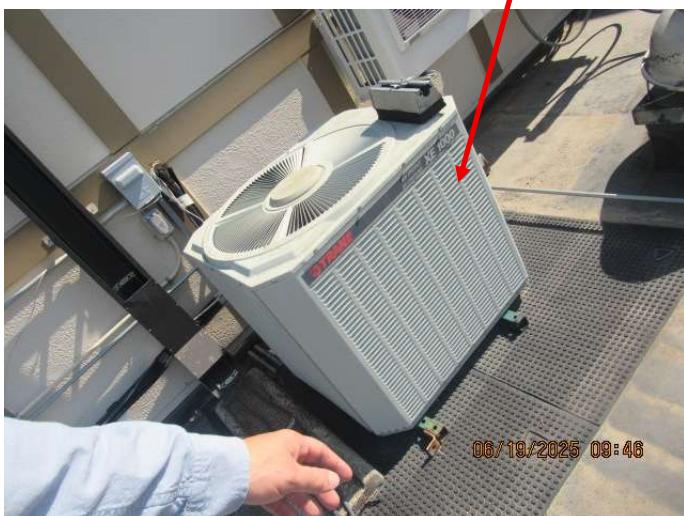
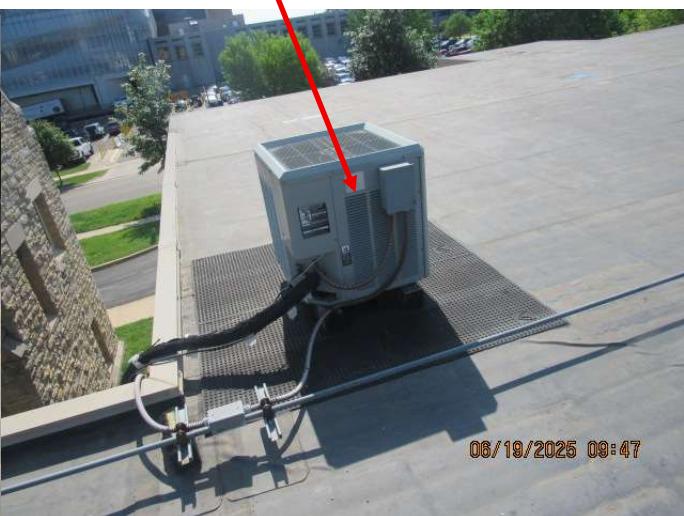
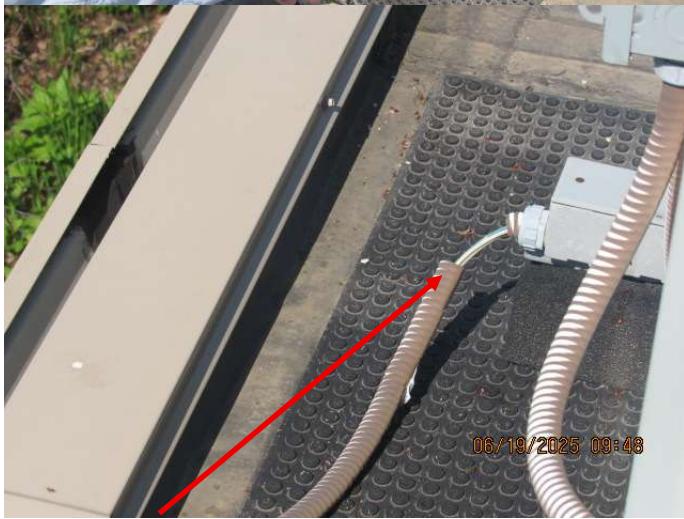
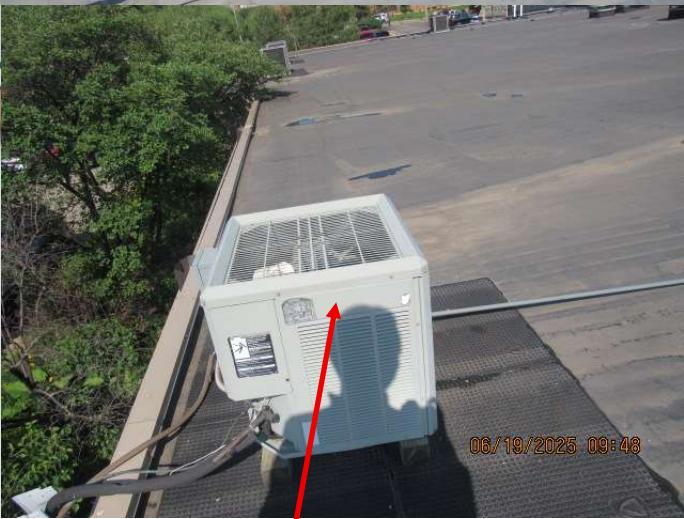
52. Some central air units provided below average cooling returns when tested. The units have damaged insulation on coolant lines and some damaged wiring conduit should be repaired on the roof. A HVAC contractor should perform service to these units.

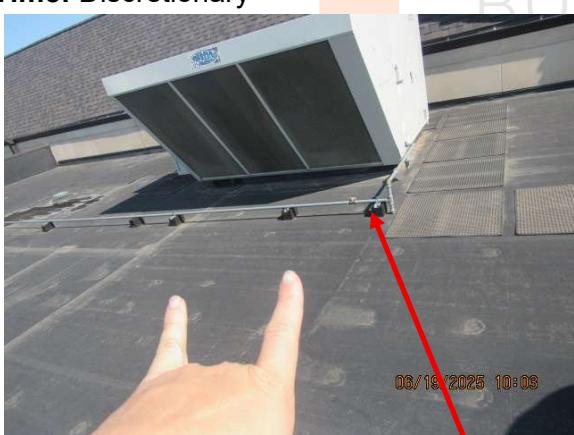
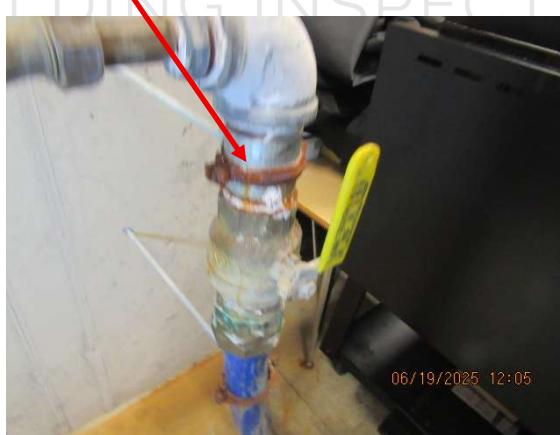
Gas supply\Gas piping

61. Gas lines should be improved at the roof. Gas lines should be yellow or marked every 5 feet with gas line indicators.

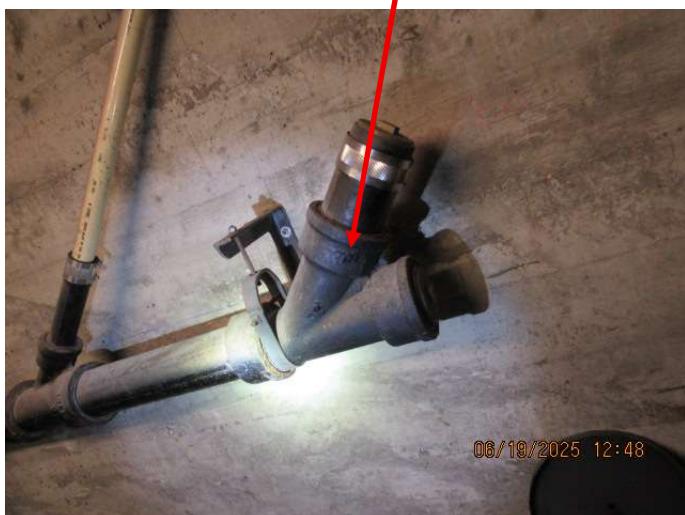
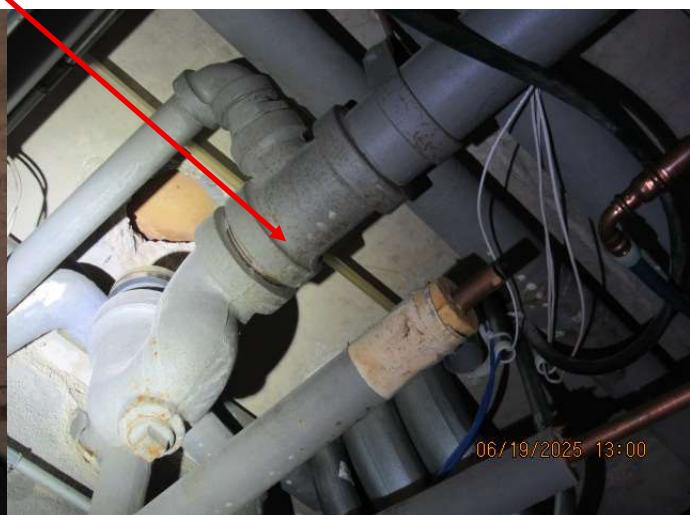
Waste plumbing\Drain piping - performance

64. Some waste plumbing shows signs of age. Repairs/replacement will be needed over time.

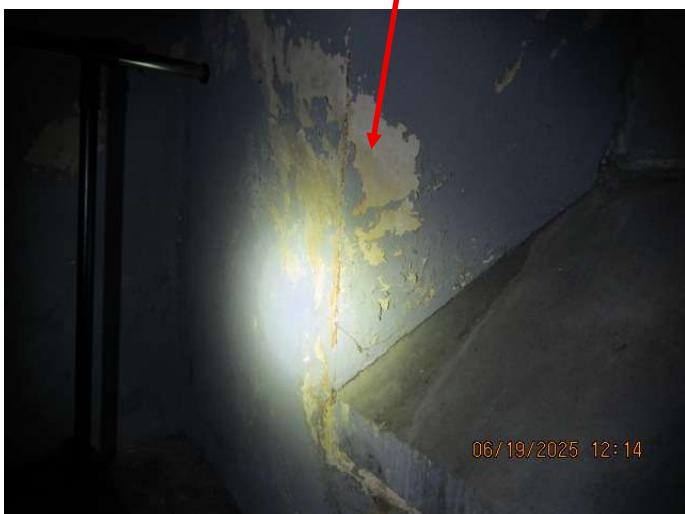
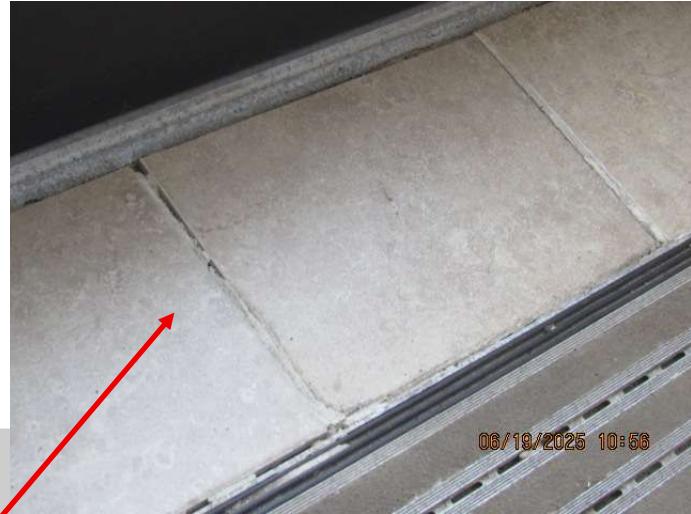
Floors\General notes

69. Broken West entry tiles should be repaired.
