INSPECTION REPORT

4 Site Building Inspections Inc

Thursday, May 29, 2025

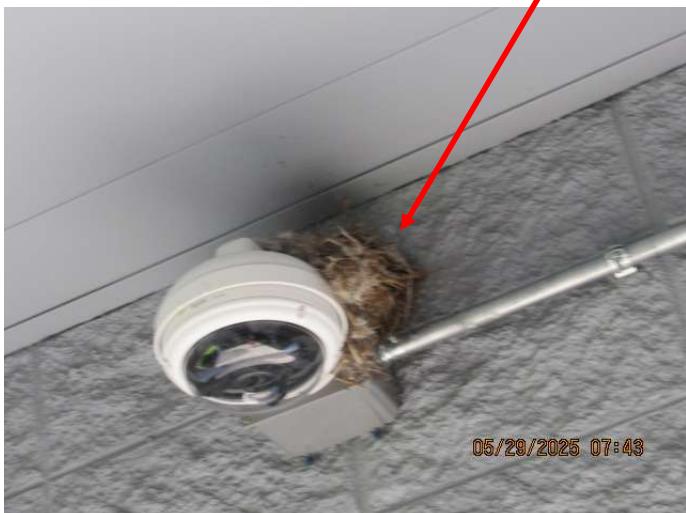
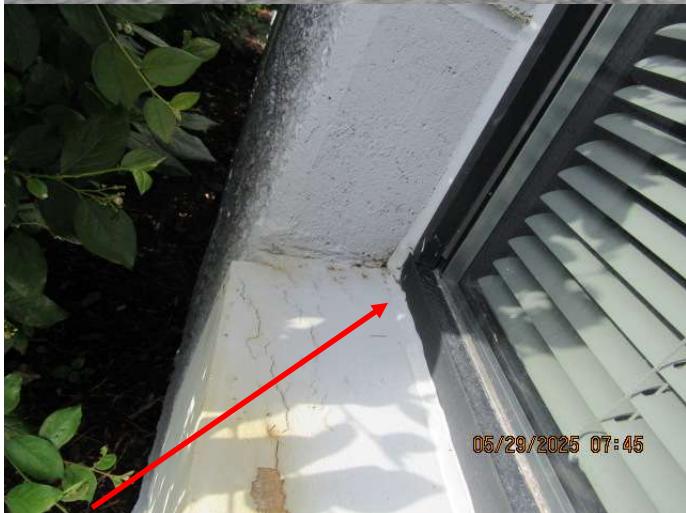
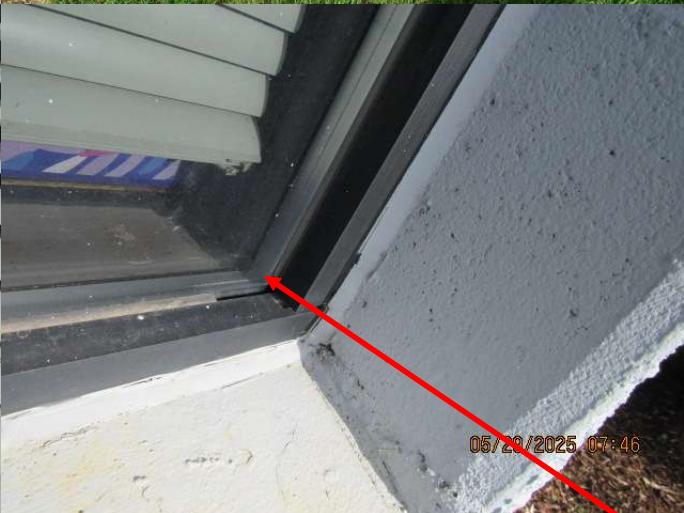
5. Some window seals and caulking is poor and could allow water intrusion. A window contractor should be consulted.

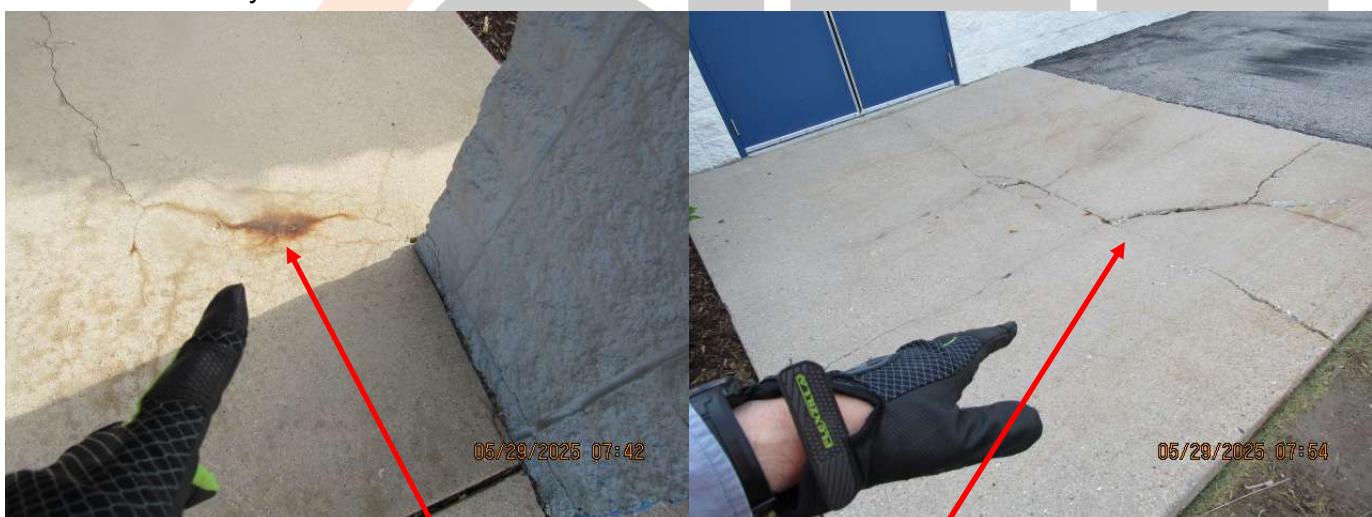
9. A concrete slab is broken and needs to be replaced at the West wall. The concrete has settled and has poor drainage at the front entry. Rust in the concrete may indicate that there are issues with rebar in the concrete. Trip hazards were noted at each entry/walkway. A concrete contractor should make repairs.

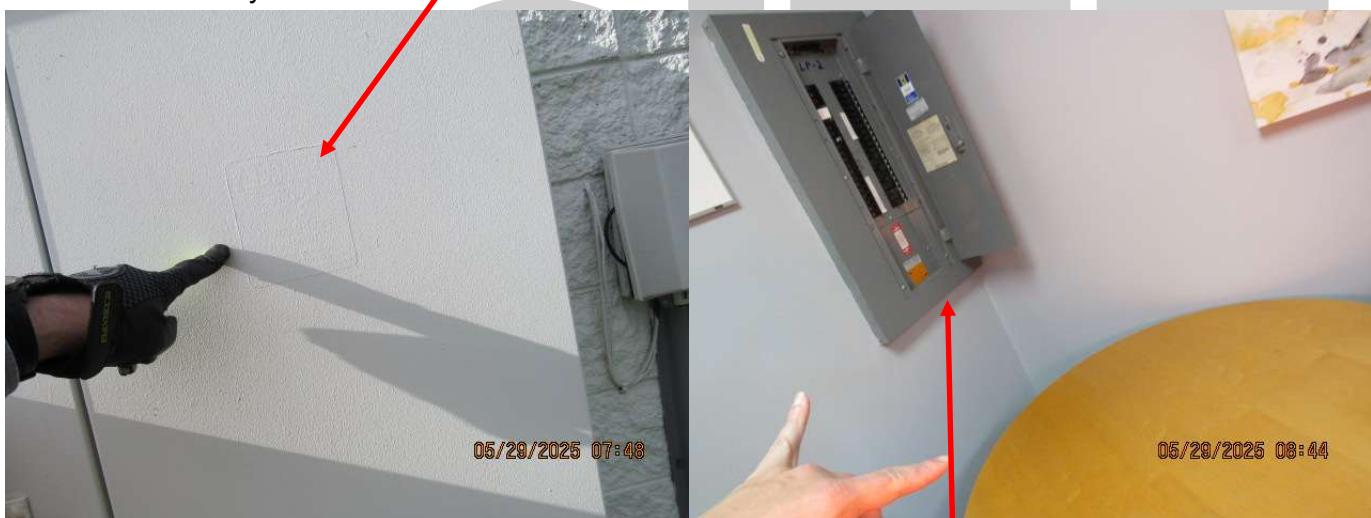
14. There should be a workspace in front of each electrical panel that is 3 feet deep and 2.5 feet wide. There should be nothing in front of each panel.

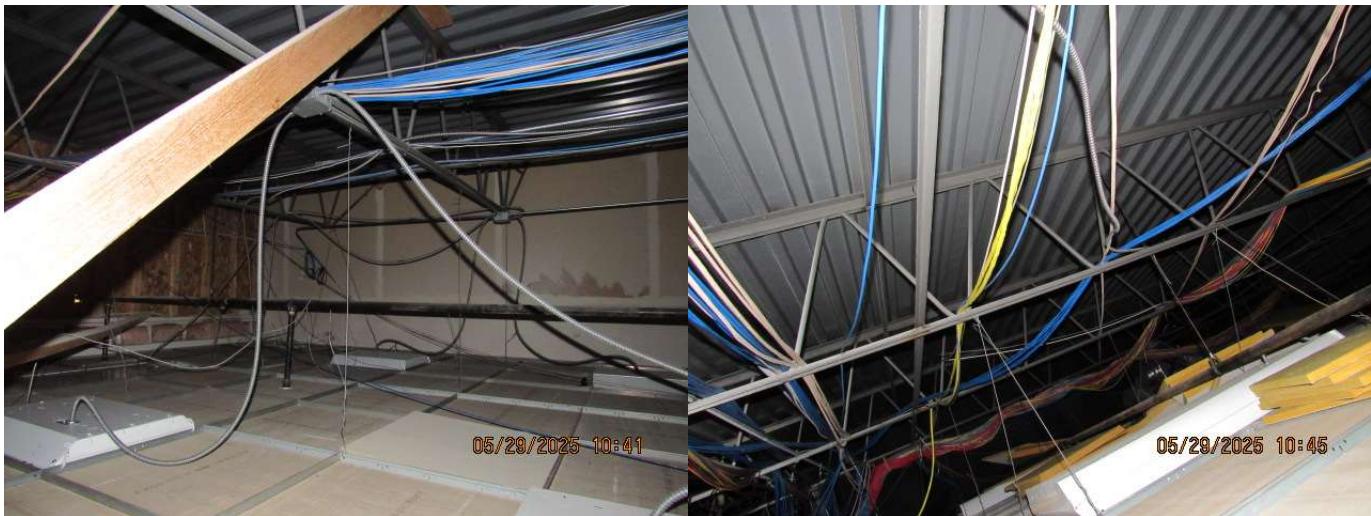
29. Discharge for various fan vents could not be fully verified/located.

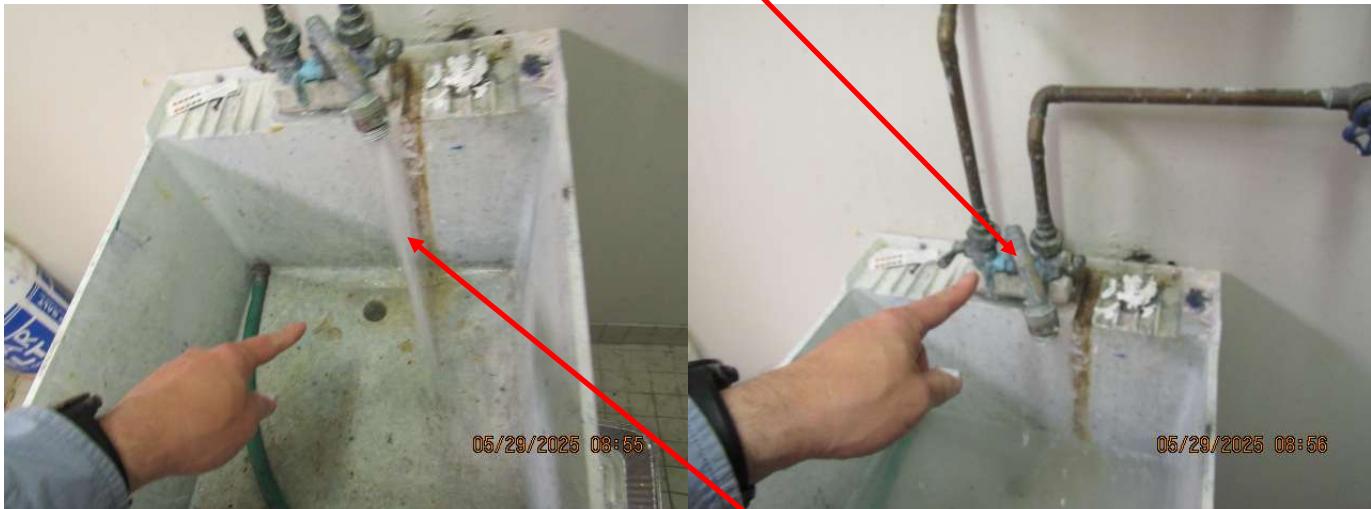
37. The sink was observed to drain slowly, suggesting that an obstruction may exist.

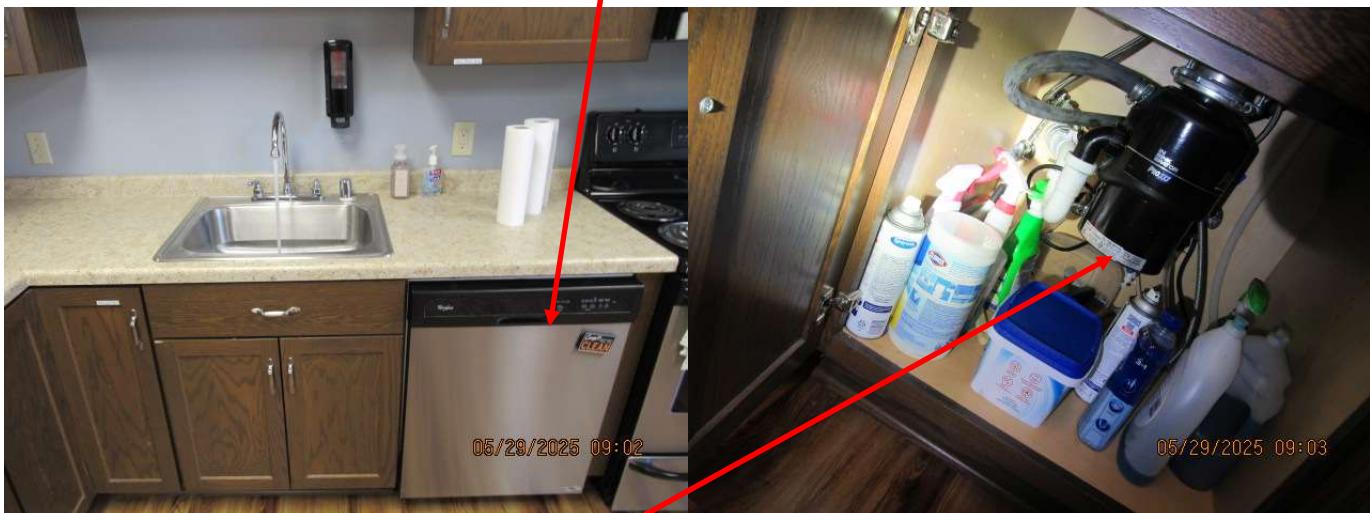
51. Old waste disposal was noted.
